**Forestry England**  
**Upper Cannop Pond**  
**Lydney, Gloucestershire**

**Report on an Inspection under Section 10(3) of the  
Reservoirs Act 1975**

**December 2022**

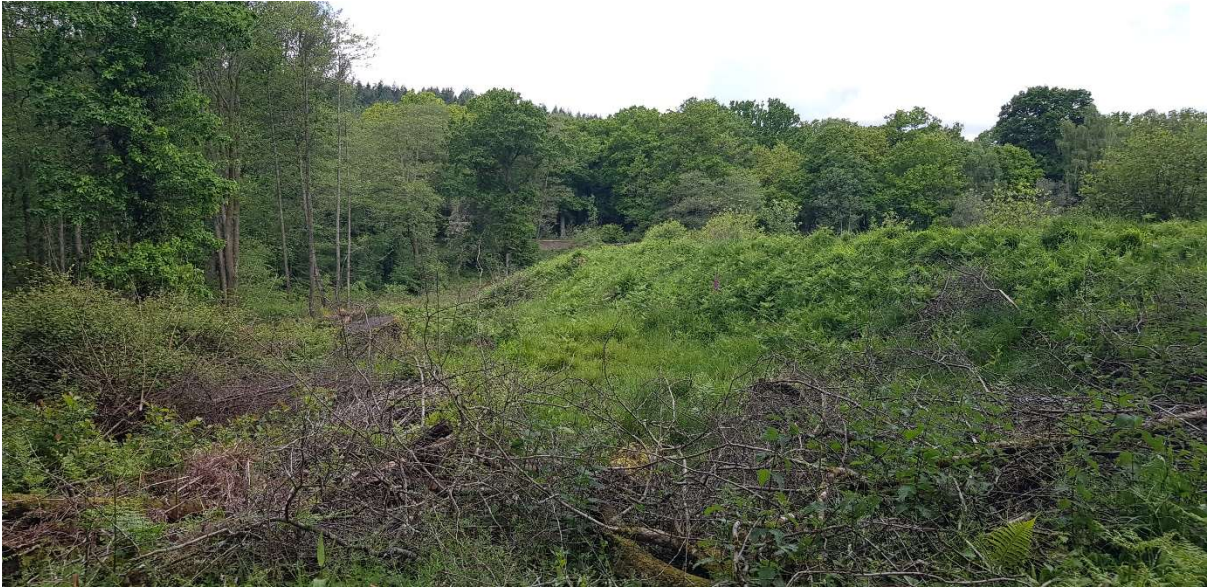
***Photograph 1: General view of embankment***

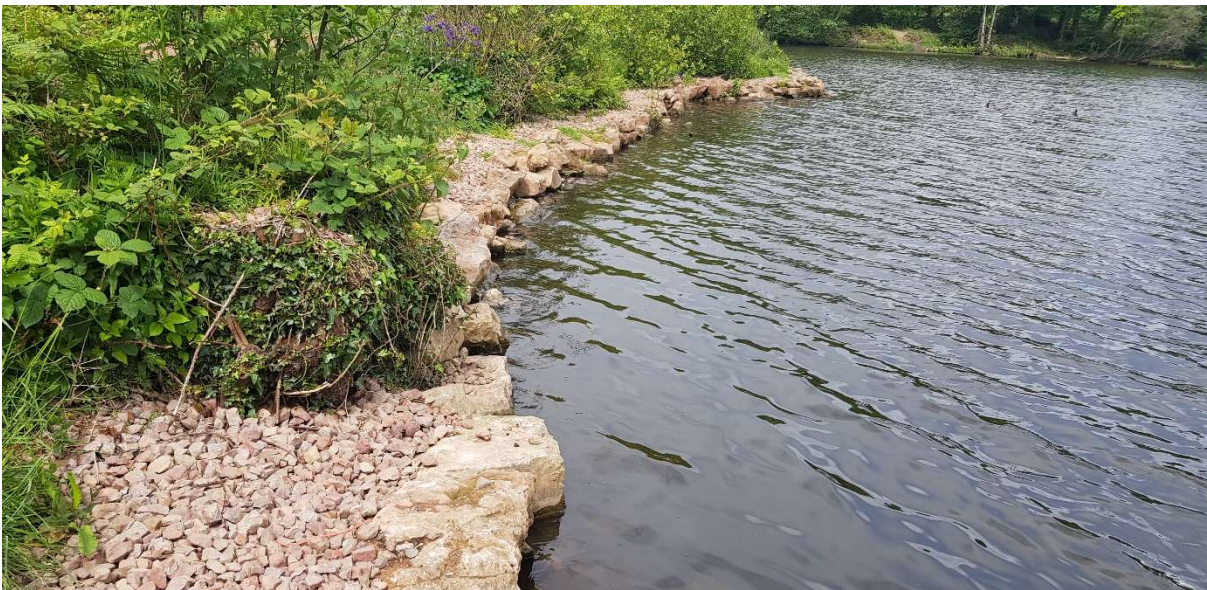
The upstream face could only be inspected above water level and a detailed inspection was not possible due to the extent of vegetation. However, from what could be seen, the upper section of the upstream face appeared to be in a reasonable condition with no clear signs of any significant settlement, movement or damage due to wave action. The current erosion protection along the upstream face consists of large stone blockwork infilled with smaller stone. The blockwork appeared to be in a satisfactory condition and reducing wave erosion of the face.

***Photograph 2: Embankment upstream face with stone block protection and vegetation growth***

- a) the trees and shrubs on the upstream embankment face be removed and cut stumps be treated with a suitable herbicide to prevent regrowth.
- b) wild boar activity be monitored at the reservoir and appropriate action be taken if damage to the embankment is occurring.

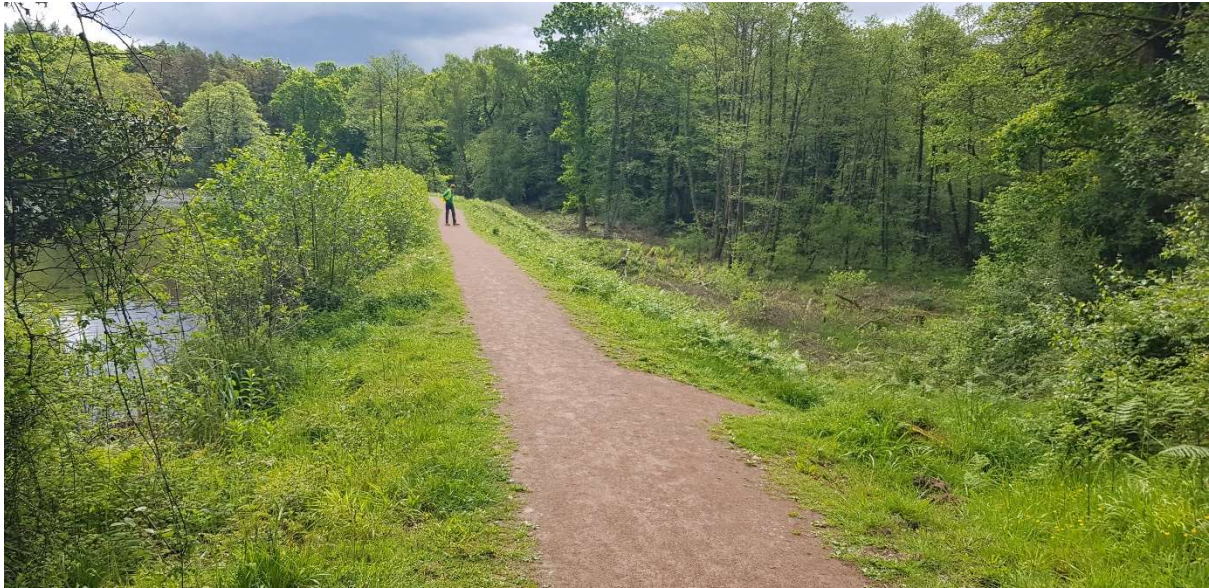
The crest is in a satisfactory condition with a reasonable line and level. The majority of the crest is at a level of around 70m AOD although the right end of the embankment is generally higher than this and the left, by the spillway, is lower. The lowest point of the embankment is immediately to the left of the spillway (69.54m AOD).

The footpath roughly follows the crest of the embankment and whilst in a good condition it is mainly of stone and bare earth which could be susceptible to erosion over time. The grass verges on either side of the footpath were well kept.

***Photograph 3: Embankment crest***

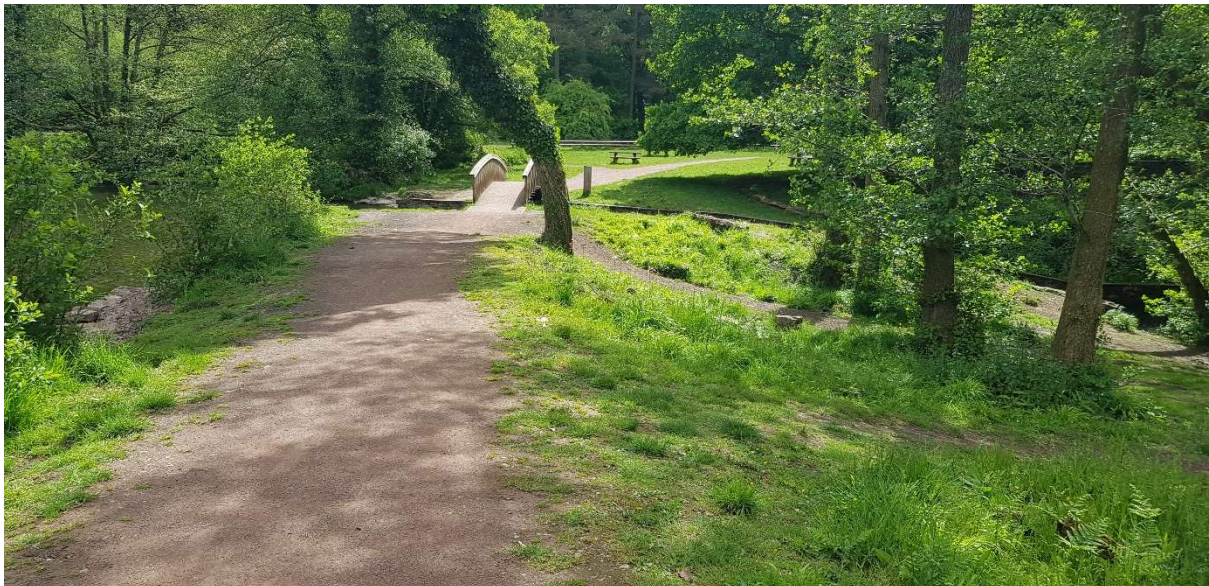
***Photograph 4: Embankment crest looking towards spillway on left abutment***

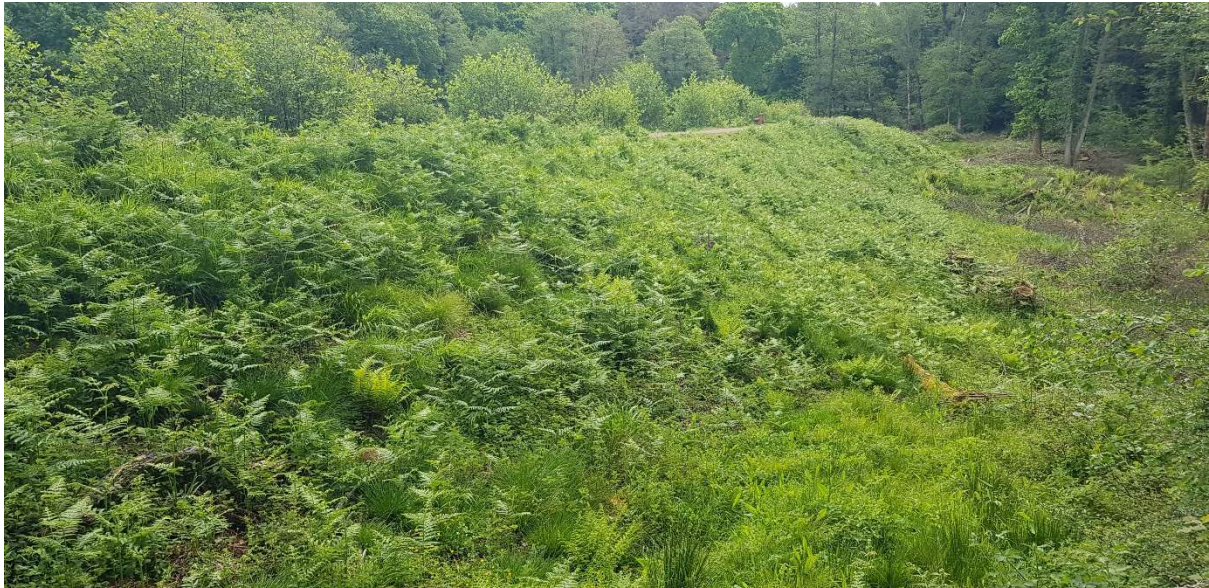
***Photograph 5: Embankment downstream face with significant vegetation growth***

**I recommend that grass growth be encouraged on the downstream face of the embankment through regular cutting and that it be maintained at a length of between 50mm and 200mm to allow adequate inspection.**

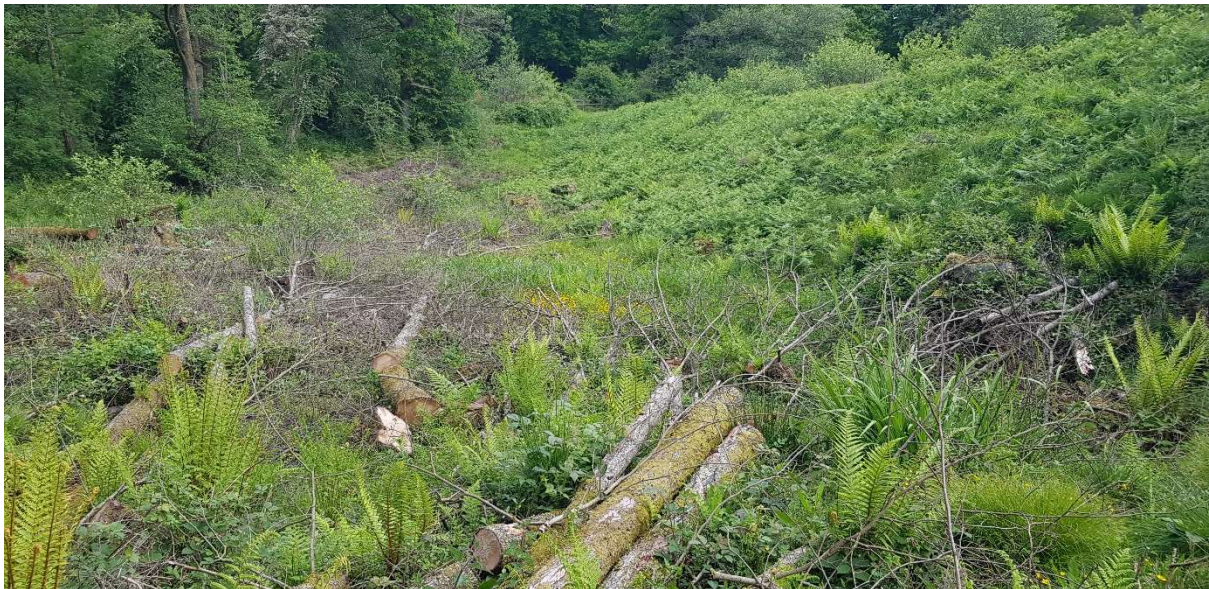
***Photograph 6: Embankment downstream toe with significant vegetation growth and cut tree logs***

**I recommend that all tree logs be removed from at least 5m out from the toe of the embankment and grass growth be encouraged through regular cutting and that it be maintained at a length of between 50mm and 200mm to allow adequate inspection.**

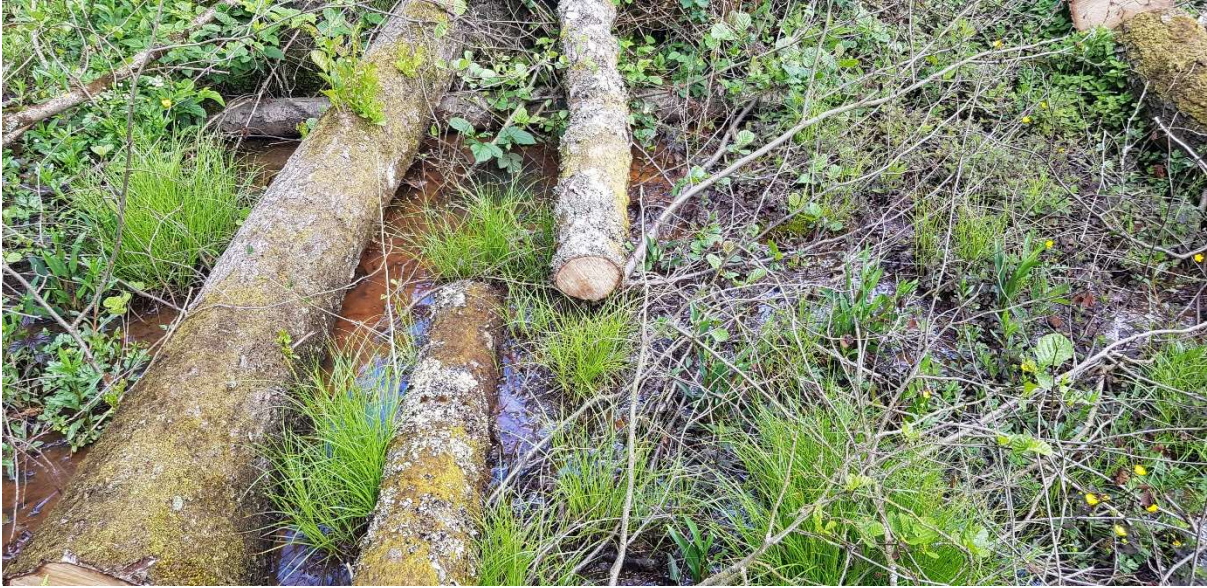
***Photograph 7: Wet area downstream of embankment toe***

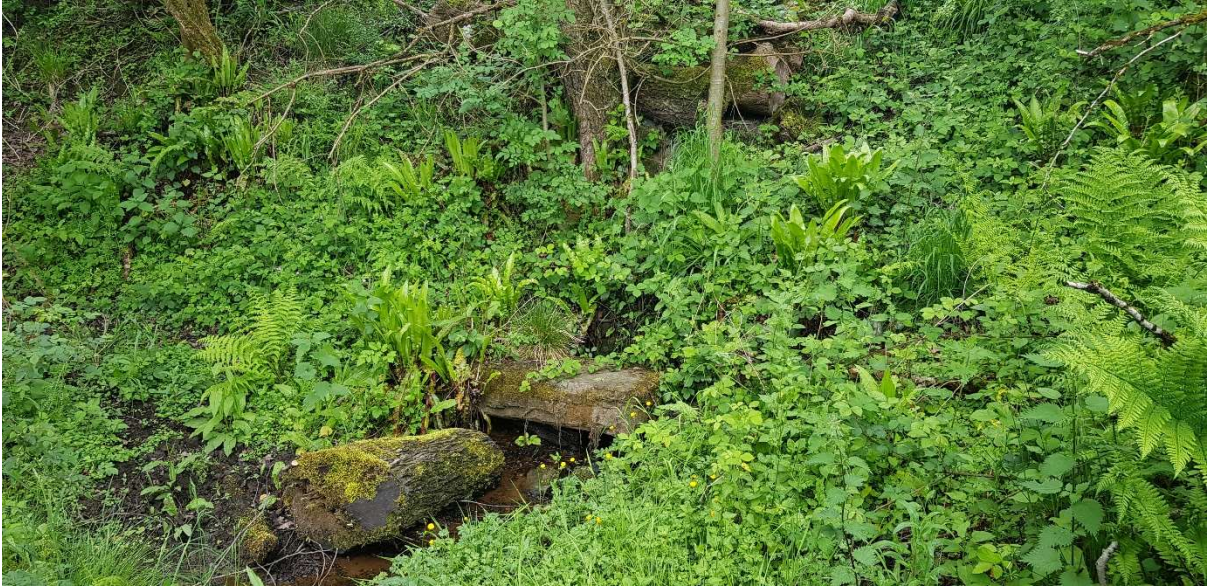
In addition, there is a drainage ditch downstream of the right embankment mitre associated with a drainage pipe that passes under the B4234. It appears that this pipe takes drainage flows from the catchment on the west side of the road. This drain could bring a reasonable amount of water into the area downstream of the embankment so it is essential that it is maintained so that it does not contribute to the drainage issues in the area as far as possible. **I recommend that the drainage ditch from the pipe that passes under the B4234 downstream of the right abutment is maintained to assist the drainage of the area and take water away from the embankment.**

***Photograph 9: Exit to culvert passing under B4234 and discharging to area downstream of embankment right mitre***

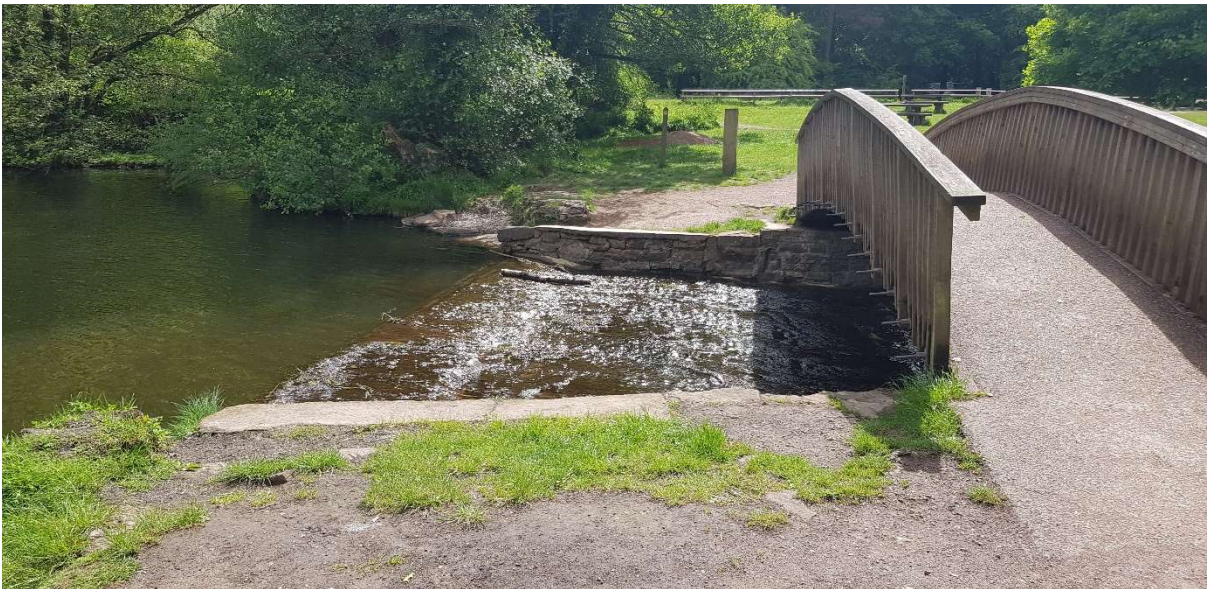
***Photograph 10: Spillway weir***

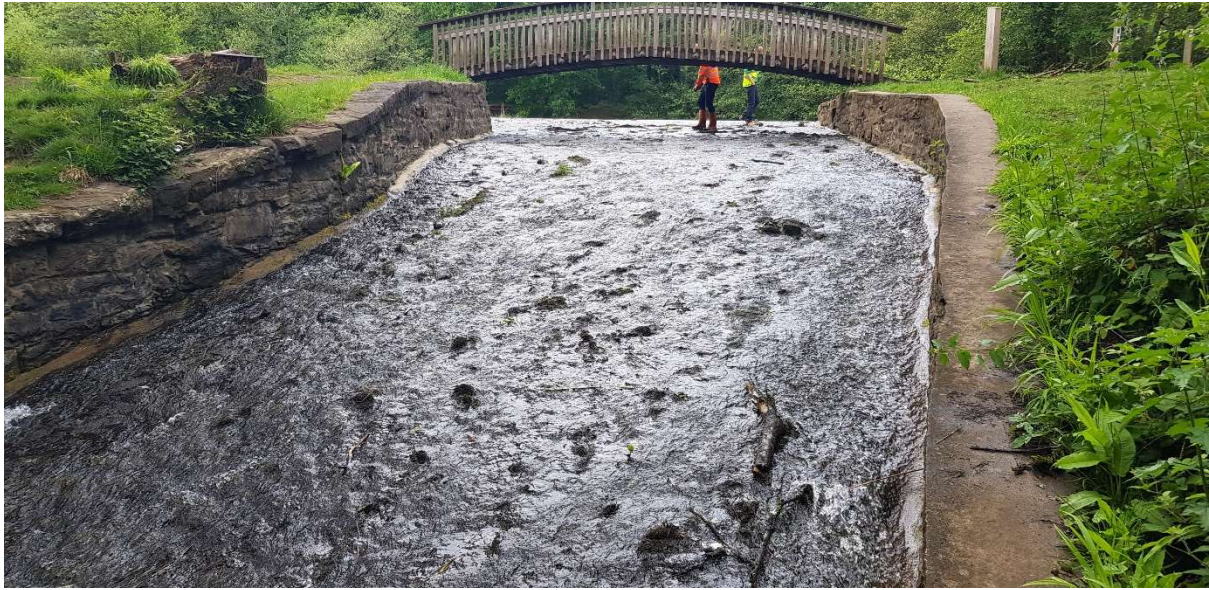
**Photograph 11: Spillway chute**

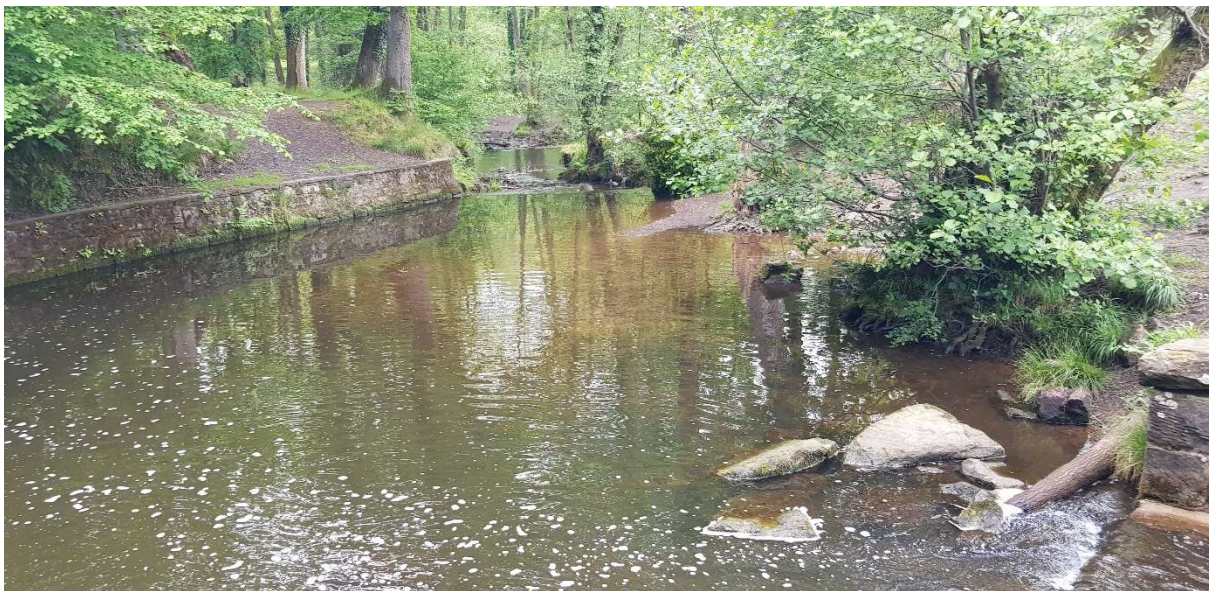
***Photograph 14: Spillway stilling basin***

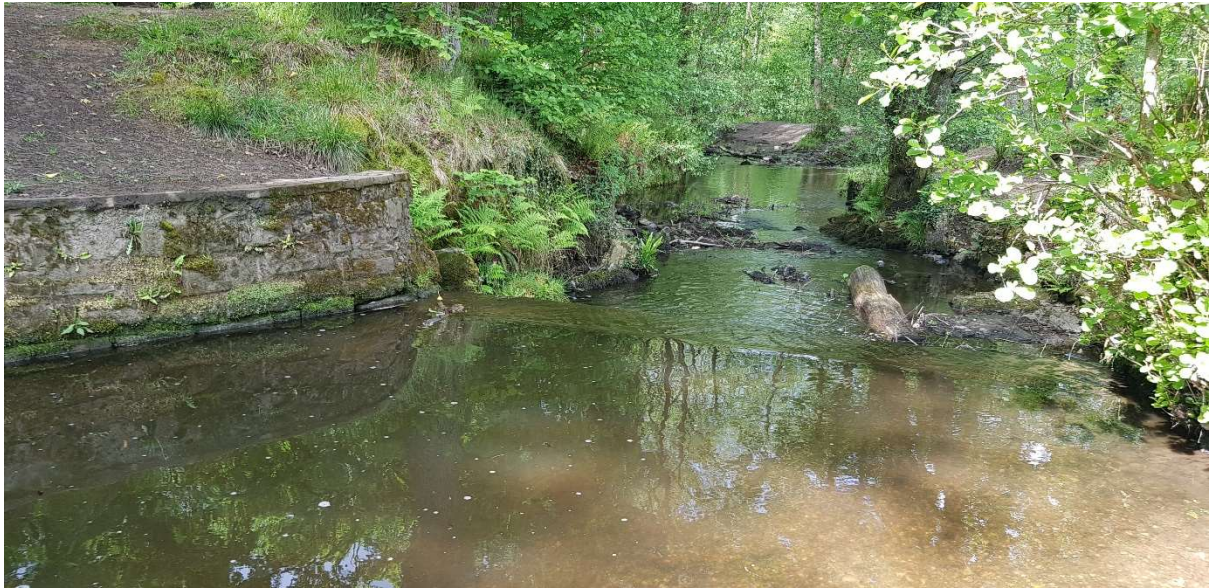
***Photograph 15: Spillway stilling basin weir and downstream channel***

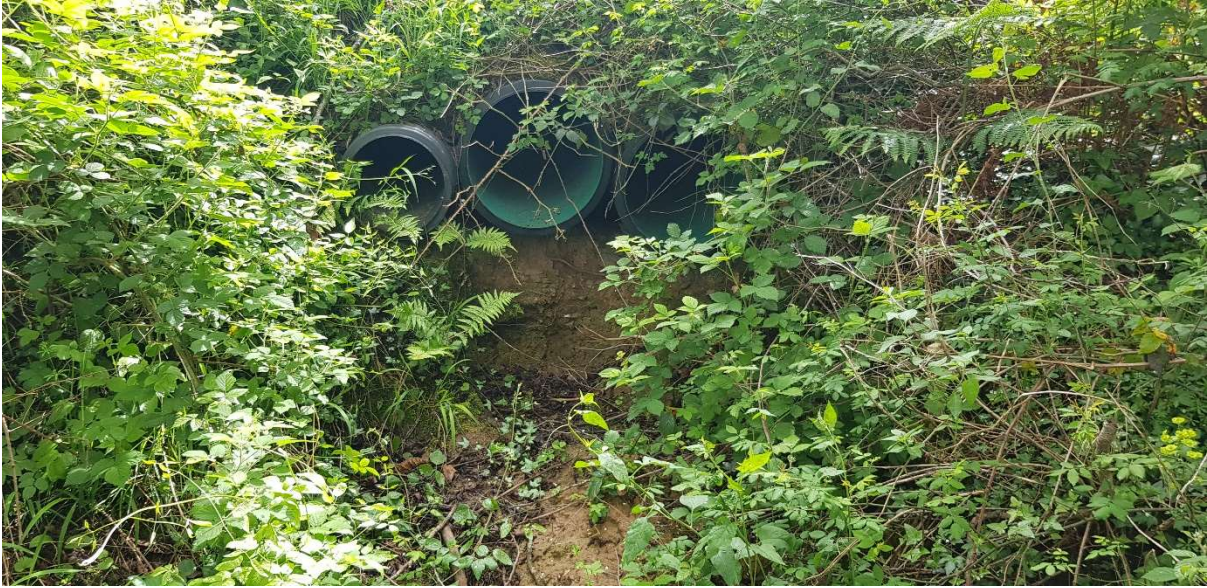
***Photograph 17: Culverts under road embankment near to left abutment bringing flows from eastern catchment into reservoir during high rainfall***

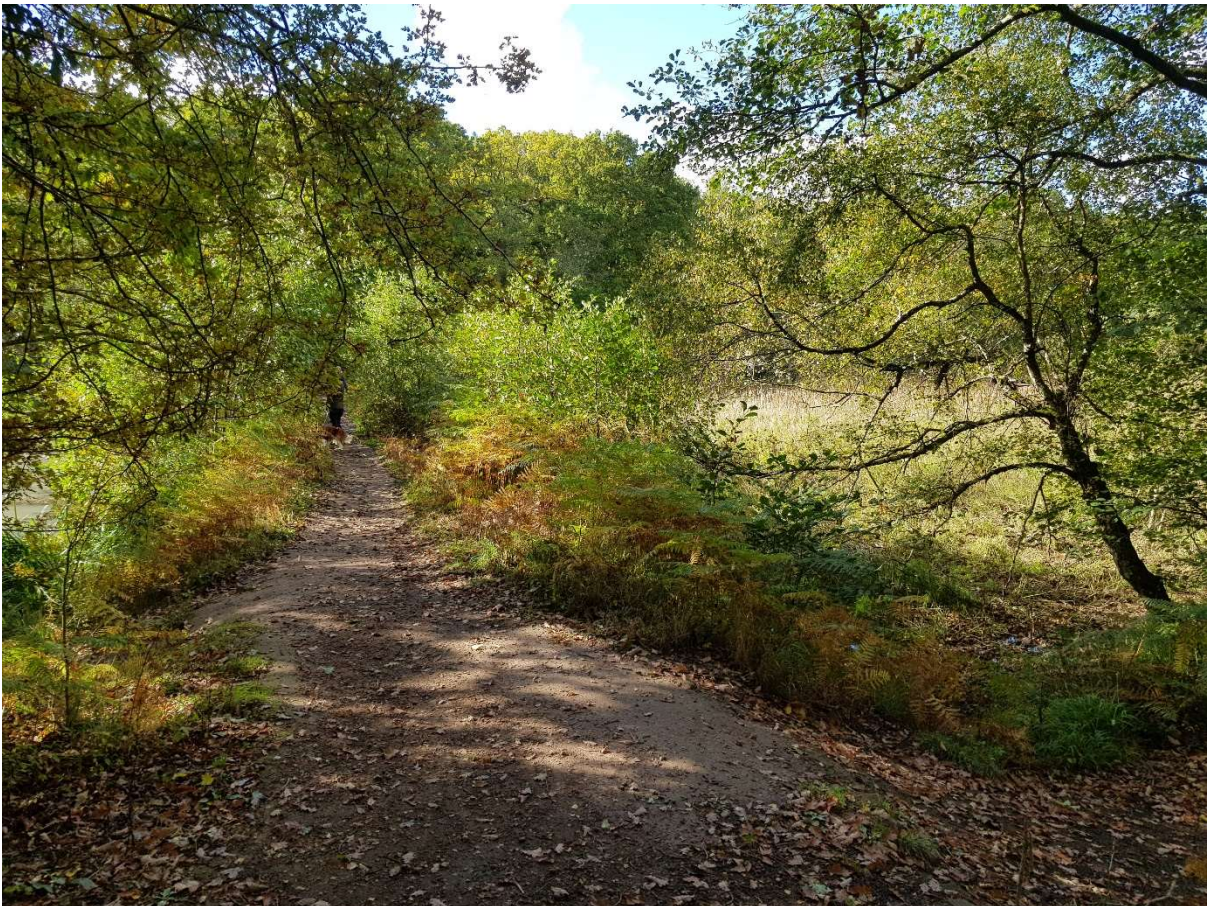
***Photograph 18: Causeway embankment dividing the north and south sides of the pond***

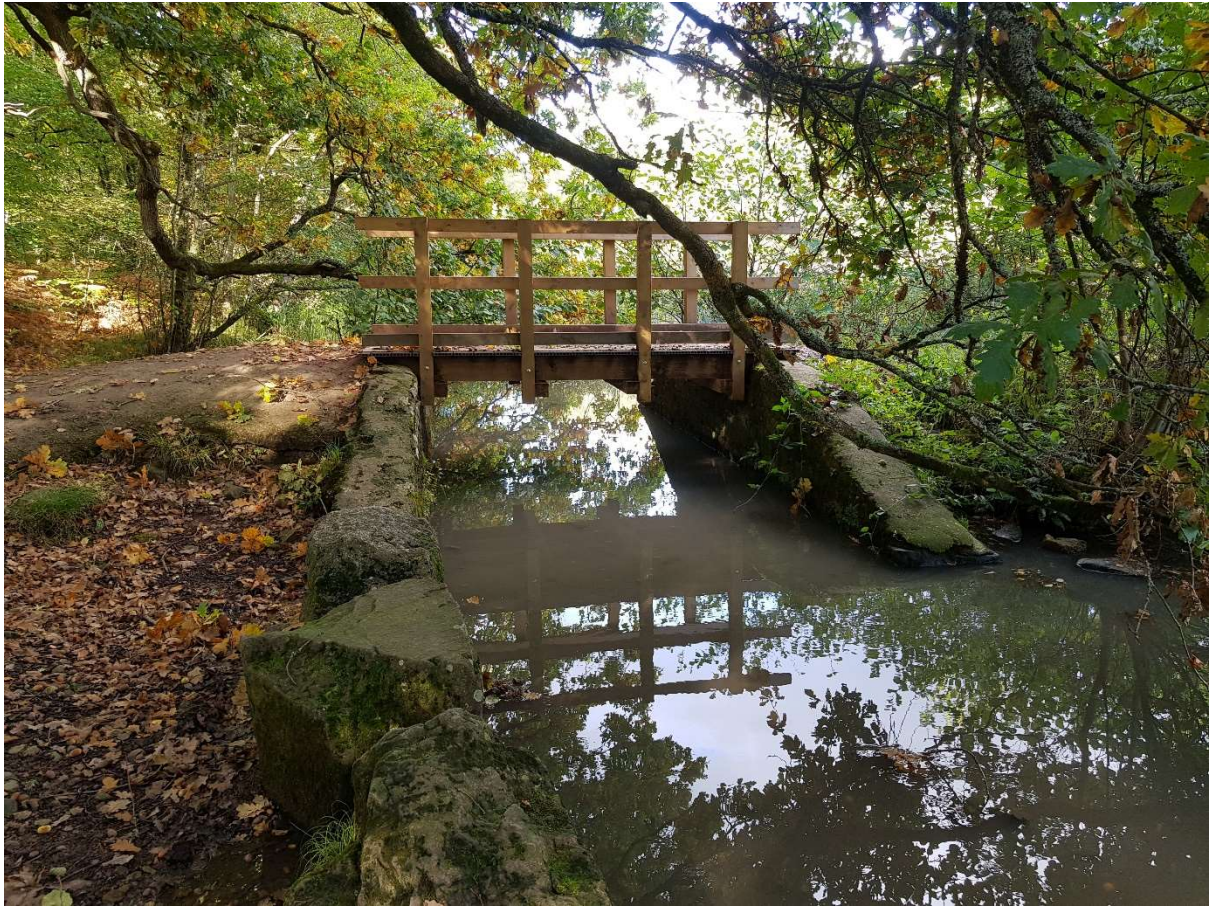
***Photograph 19: Channel through causeway embankment joining the north and south sides of the pond***
