INTRODUCTION

PROVISION OF LONG TERM REPAIR AND ENHANCEMENT WORK ON LOWER CANNOP POND DAM

2nd March 2023

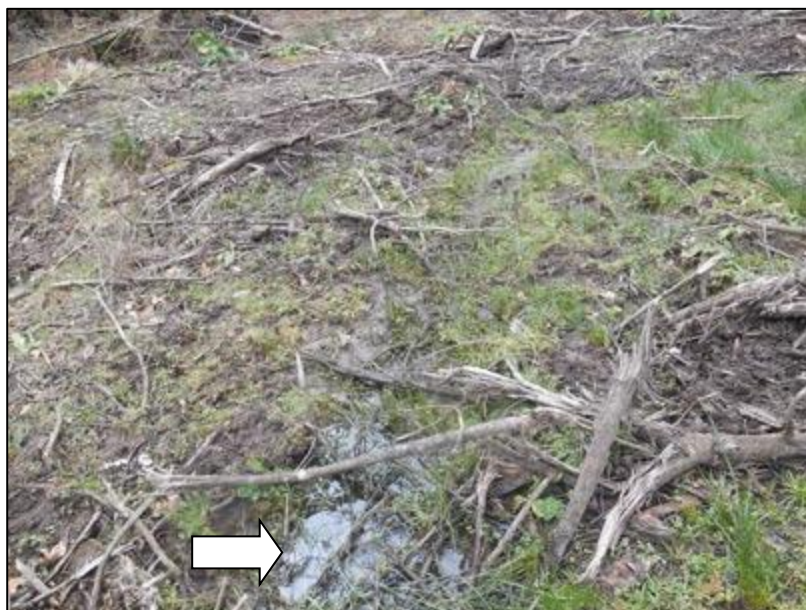
- *The dams are about 200 years old! That is not exceptional as there are hundreds of embankment dams in Great Britain of this age (and older) and they are still in service, operating satisfactorily and regularly supervised for any indications of issues arising, with remedial work undertaken before greater problems become manifest.*
- *The Lower Pond dam was built as a railway embankment and was never intended to be a water-tight structure to retain a reservoir. It is likely that there is no formal cut-off into original ground at the dam’s foundation. There is no sign of any deep-seated leakage appearing in the valley below and no evidence that this has been a problem in the past. The following photograph shows one small damp area below the downstream toe, but the cause appeared to be the lack of a drainage path from the flat area, rather than water passing through the dam.*

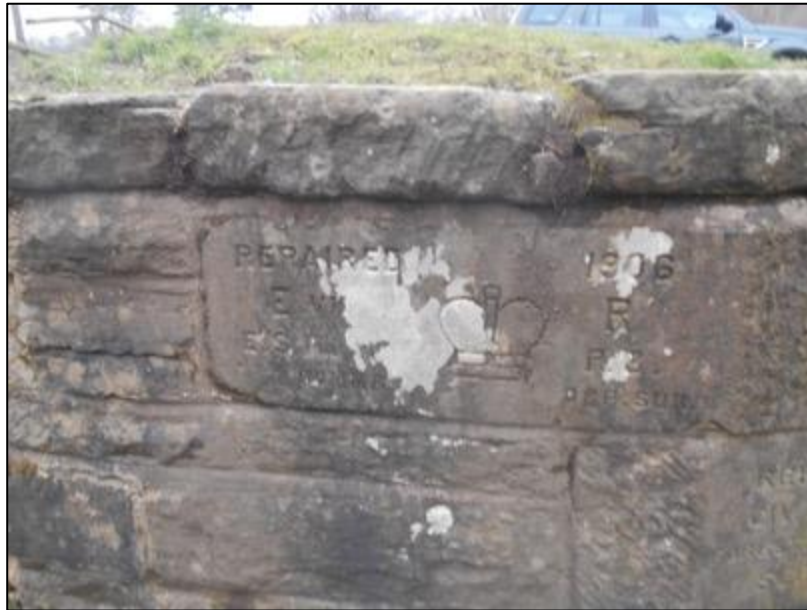
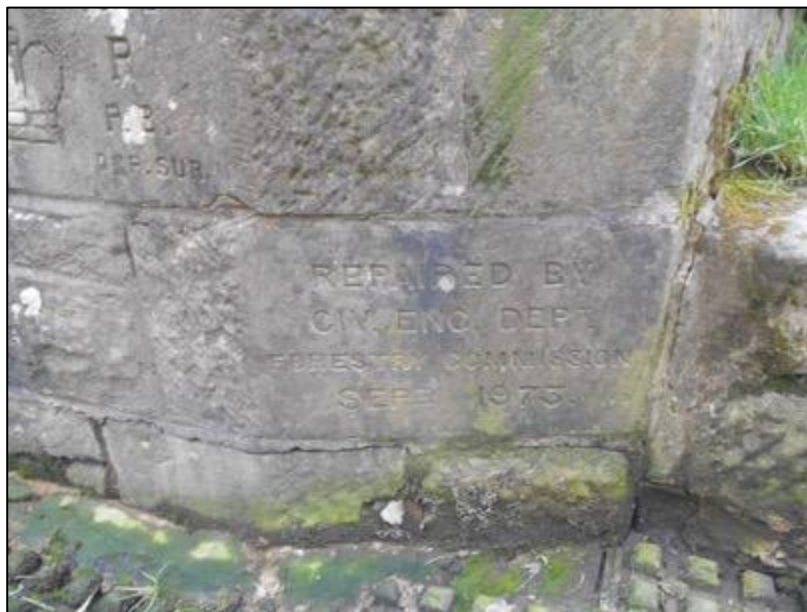
- The dam has a long history of piecemeal reactive repairs to voids within the dam embankment, including areas under the overflow weir and spillway. The following photographs bear testament to repair work in 1906 & 1973.

It appears that the repairs carried out historically have simply been to rectify damage that became apparent from time to time, rather than to address the main source of the problem! It is therefore not surprising that there have been repeated need for repairs.

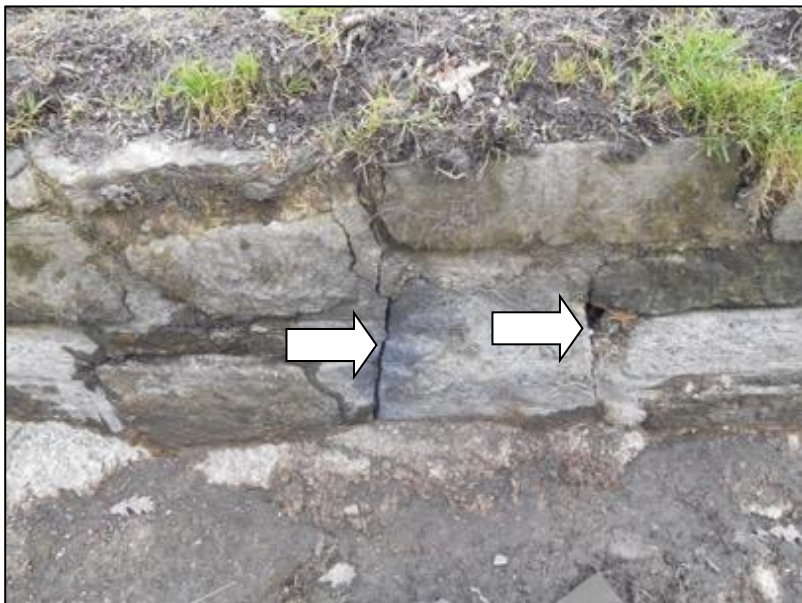
It appears that the frequency and standard of repair work has been poor, as evidenced by the following photographs, which show that in places there is scope for water to penetrate the dam with potential to cause internal erosion (in the current absence of a watertight core), leading to potential for void formation in the dam embankment from time to time (when the reservoir is returned to the overflow weir level) and the appearance of sink holes at the ground surface.

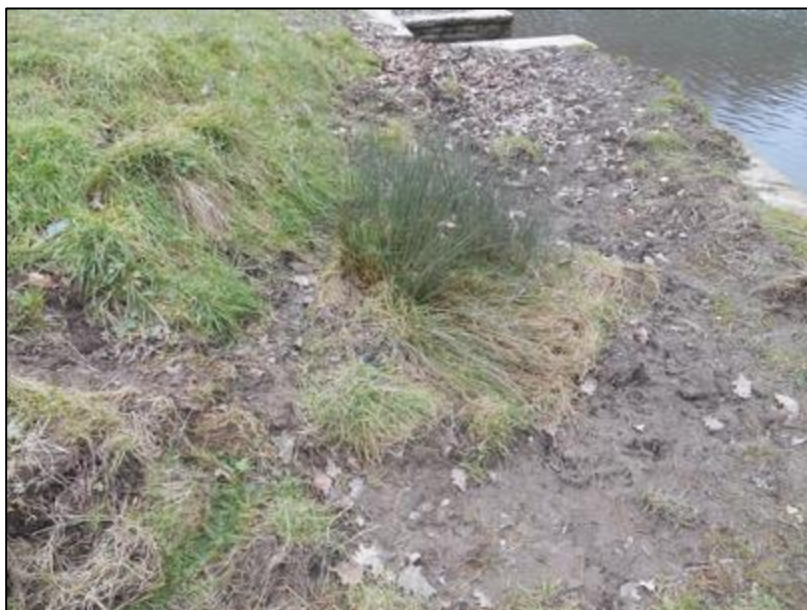
- Permanent lowering of the top water level – such as illustrated in photographs above and below, taken during my visit on 1st February 2023. The water level had been drawn down to just above the hydro-turbine intake culvert's invert. I understand that this would be acceptable to the Angling Club and probably most, if not all, who currently enjoy the pond, as it appeared not to expose unattractive muddy areas around the pond's margins.

- Probably (in conjunction with the above); raise the dam crest level over at least a 2m width along the entire upstream face of the dam. The cost of this will be dependent on the extent but is unlikely to cost more than £100,000. This will allow the attenuation in the pond to increase, with potential to reduce downstream flooding from storm events. In the very unlikely event of a dam breach, the volume released downstream and hence the potential for damage should be reduced.

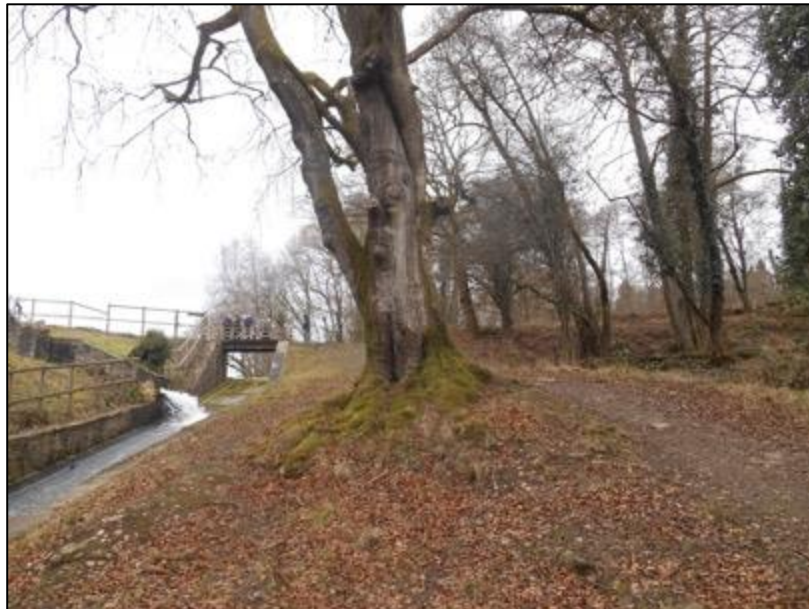
The east side of the existing spillway, would require tree felling and some regrading work to allow this as illustrated in the photograph below. It is unlikely to be viable on the west side of the spillway unless the hydro- turbine facilities are removed.

- A new overflow weir and some/all (subject to the results of a GPR survey) of the spillway outlet channel would need to be reconstructed. The simple solution is a common overflow arrangement to deal with the expected range of design flood flows. However, a competent dams and reservoirs engineer could utilise modern tried and tested techniques to minimise the construction cost and reduce the visual impact of civil engineering construction:

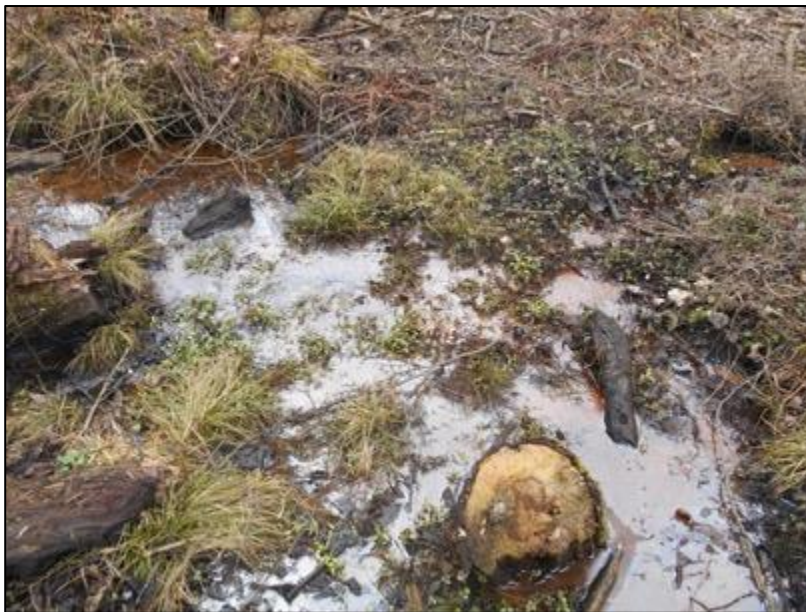
Downstream toe area – no drainage due to absence of gradient away from dam toe.

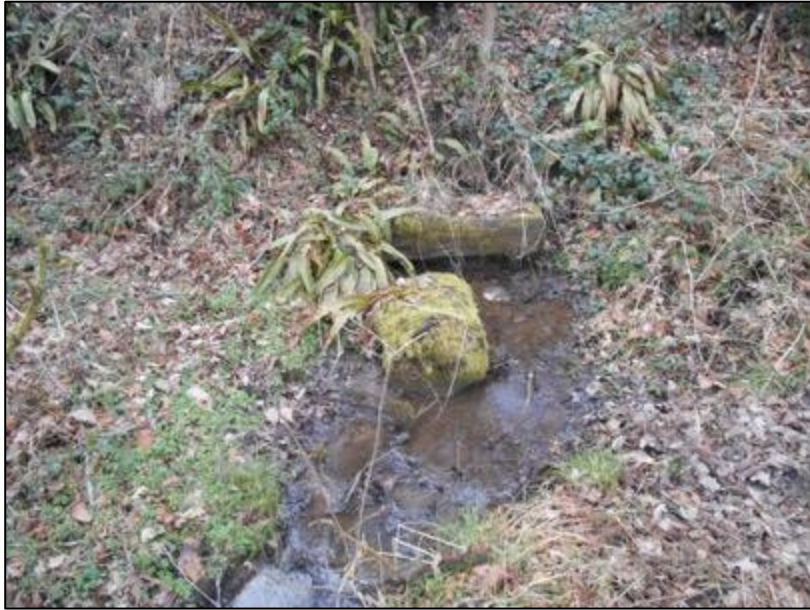
Water from road to toe area.
