LOWER CANNOP RESERVOIR

**REPORT ON AN INSPECTION UNDER SECTION 10(2) OF THE
RESERVOIRS ACT 1975**

May 2021

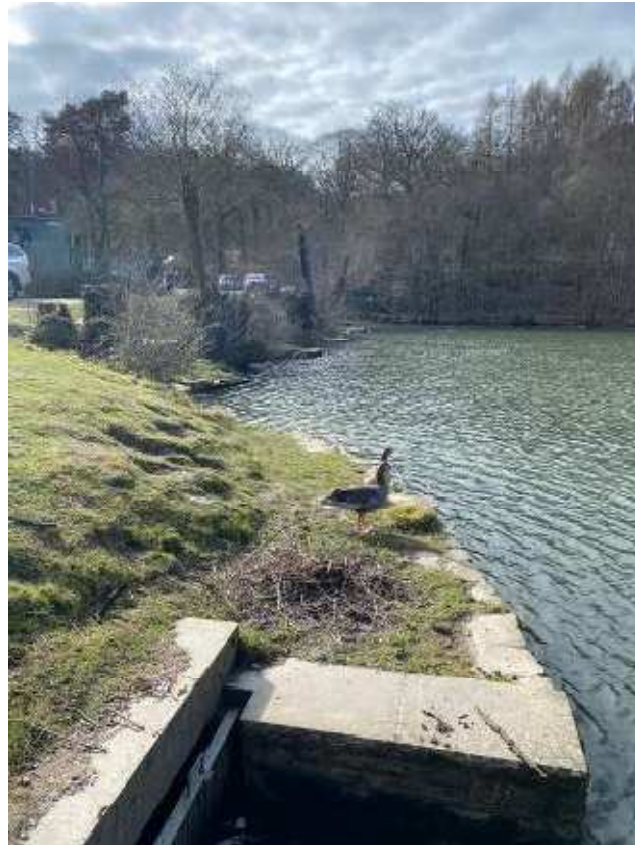
Upstream face

The upstream face general has a satisfactory line and level but does support several mature trees particularly on the water's edge. There are also a few small trees near the spillway and on the downstream face. The mature trees have been cut back well. **I recommend mature trees continue to be managed so that they do not become too big or out of balance. I recommend that all small saplings, brambles and trees be removed.** Large slabs of sandstone have been placed at the water's edge to prevent erosion and provide fishing platforms and seem to be in a satisfactory condition. **I recommend any erosion around the fishing platforms be repaired as and when necessary.**

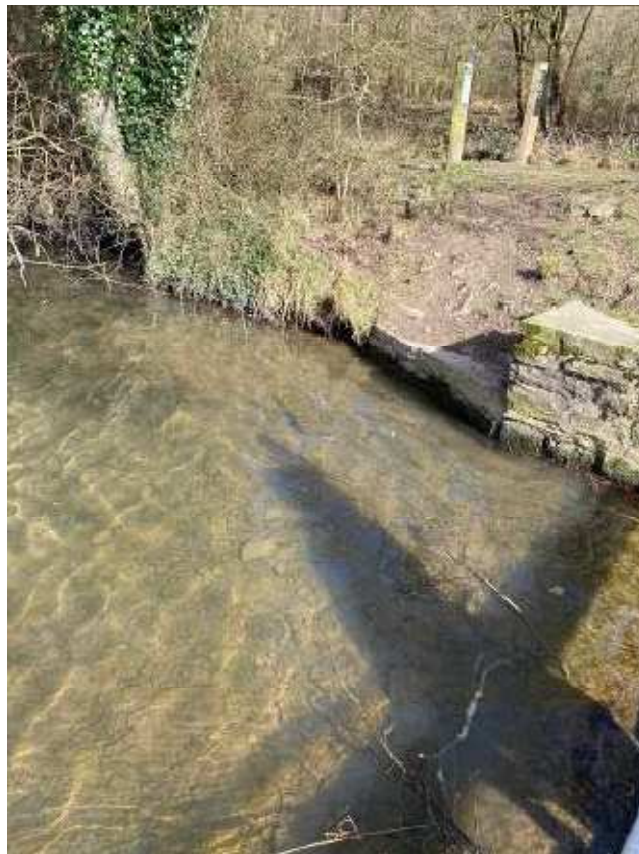
Undermining – upstream left side

- (i) the trees on the left-hand side of the approach to the weir be lopped and/or trimmed.
- (ii) the area at the end of the left hand approach wall be repaired.
- (iii) the large tree near to the left-hand wall be removed.

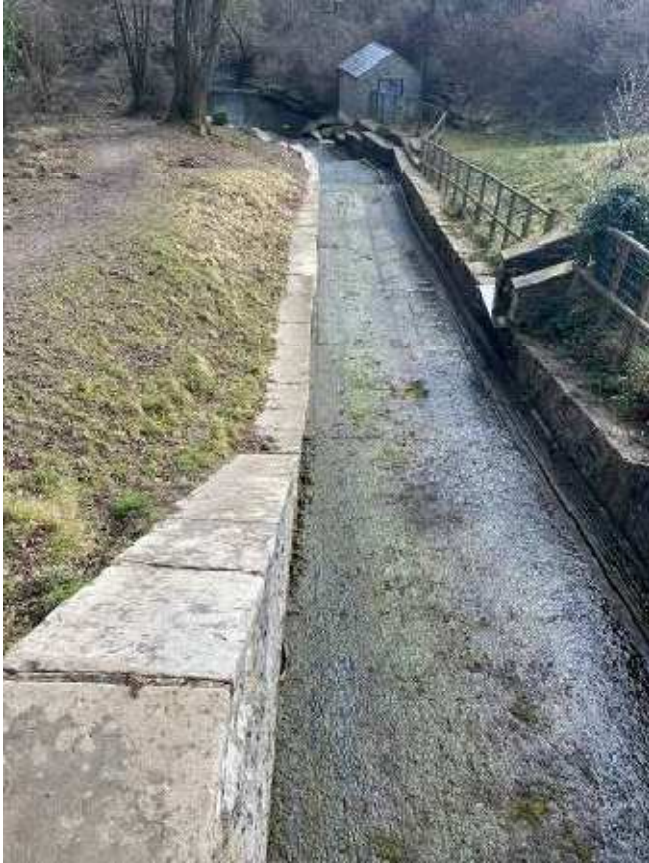
Left wall

Remedial works have been carried out in the past in the area adjacent to the weir on the right-hand side and the left wall seems to have been rebuilt.
