Forestry England

Cannop Ponds

Heritage Impact Assessment

Reference: 286412-ARP-XX-XX-RP-YX-6101

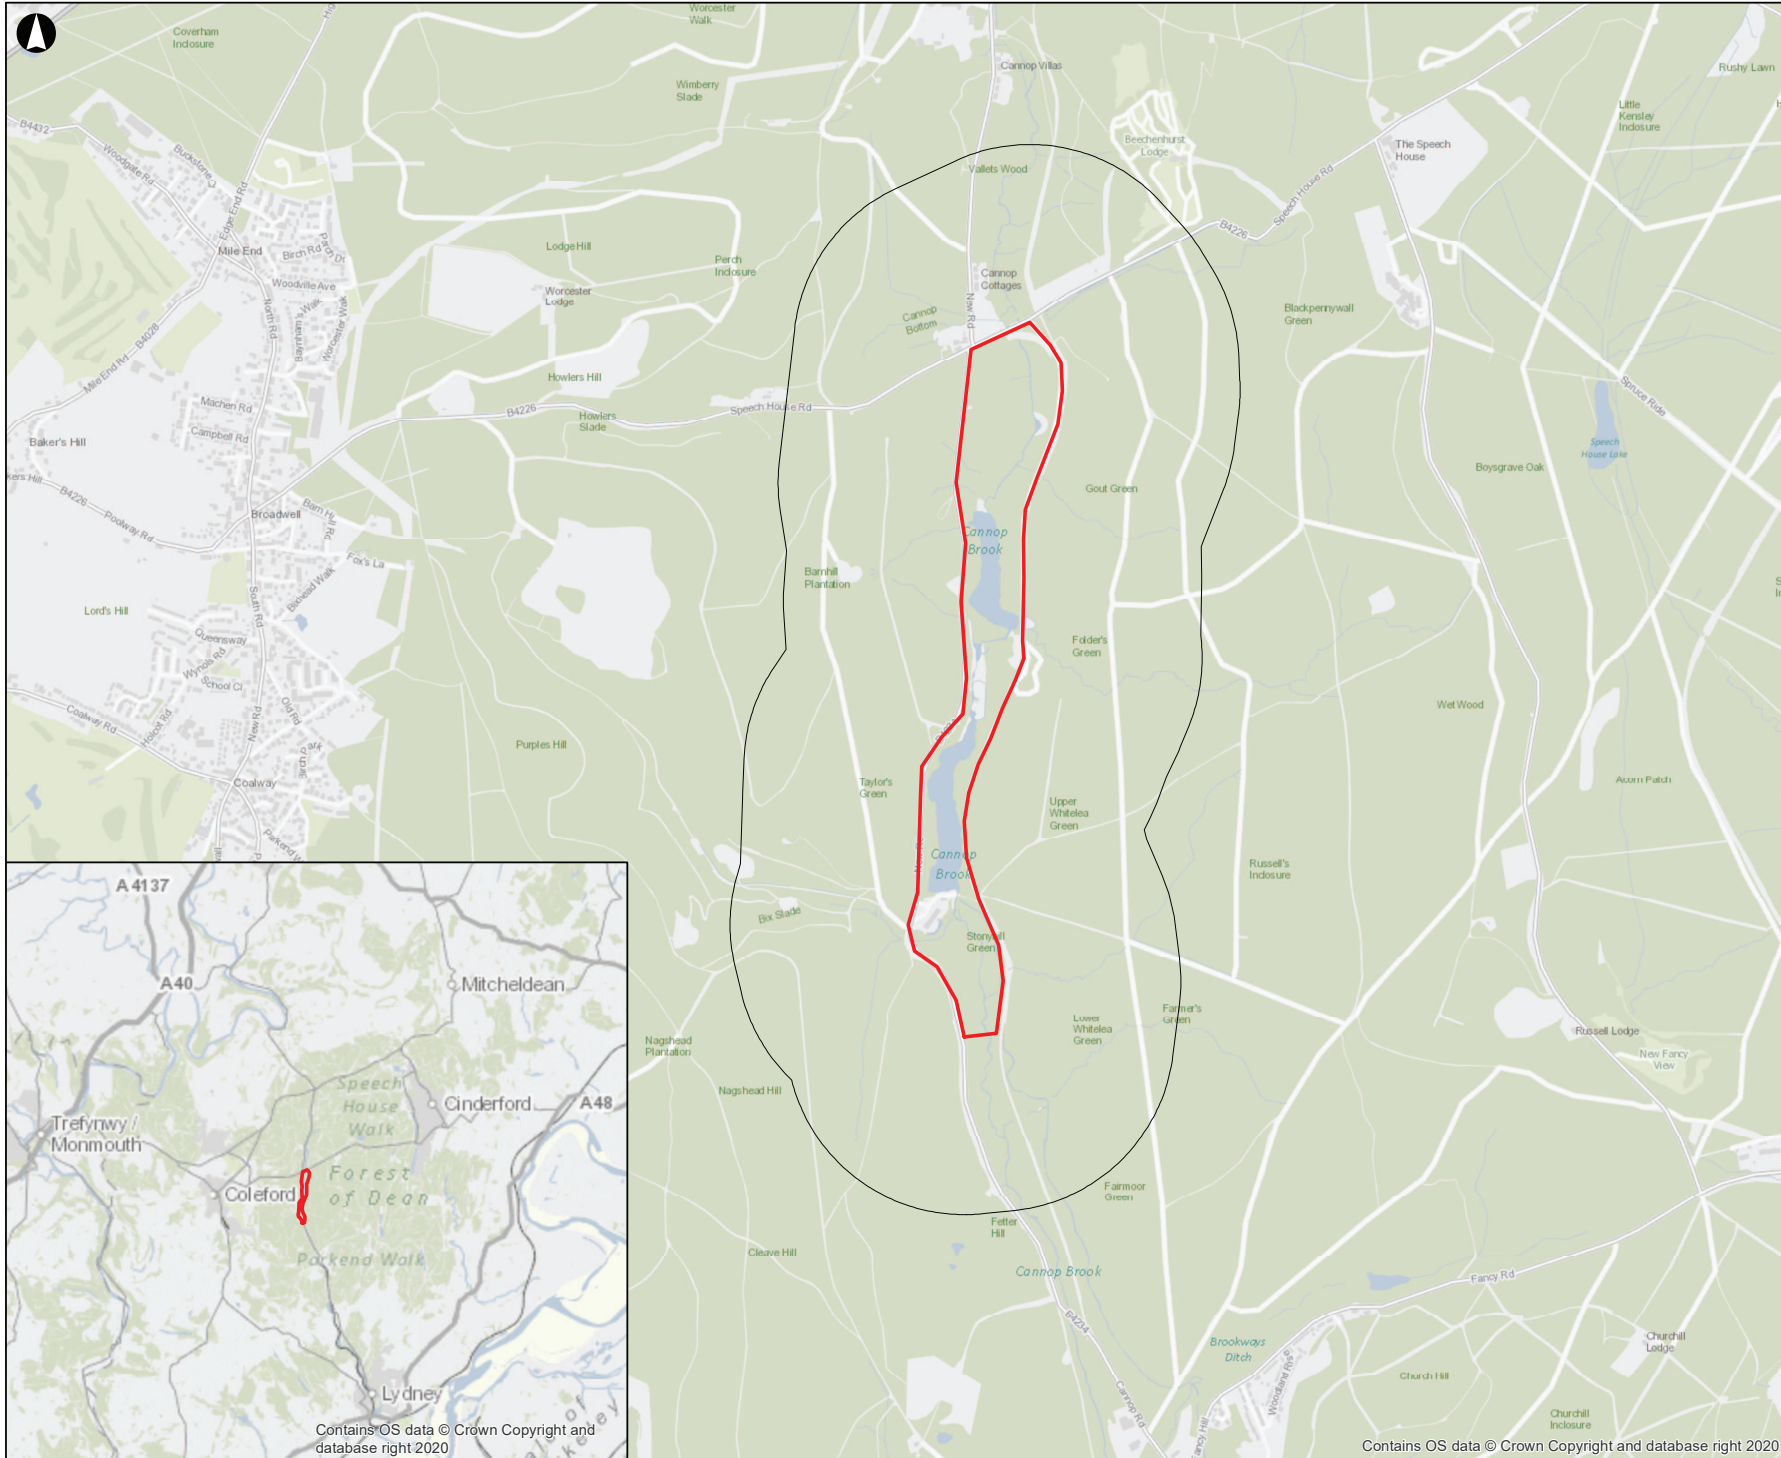
Figure 1: Cannop Ponds

The site, for the purposes of this assessment, is an approximately 2km corridor around the Ponds and Cannop Brook (Figure 1).

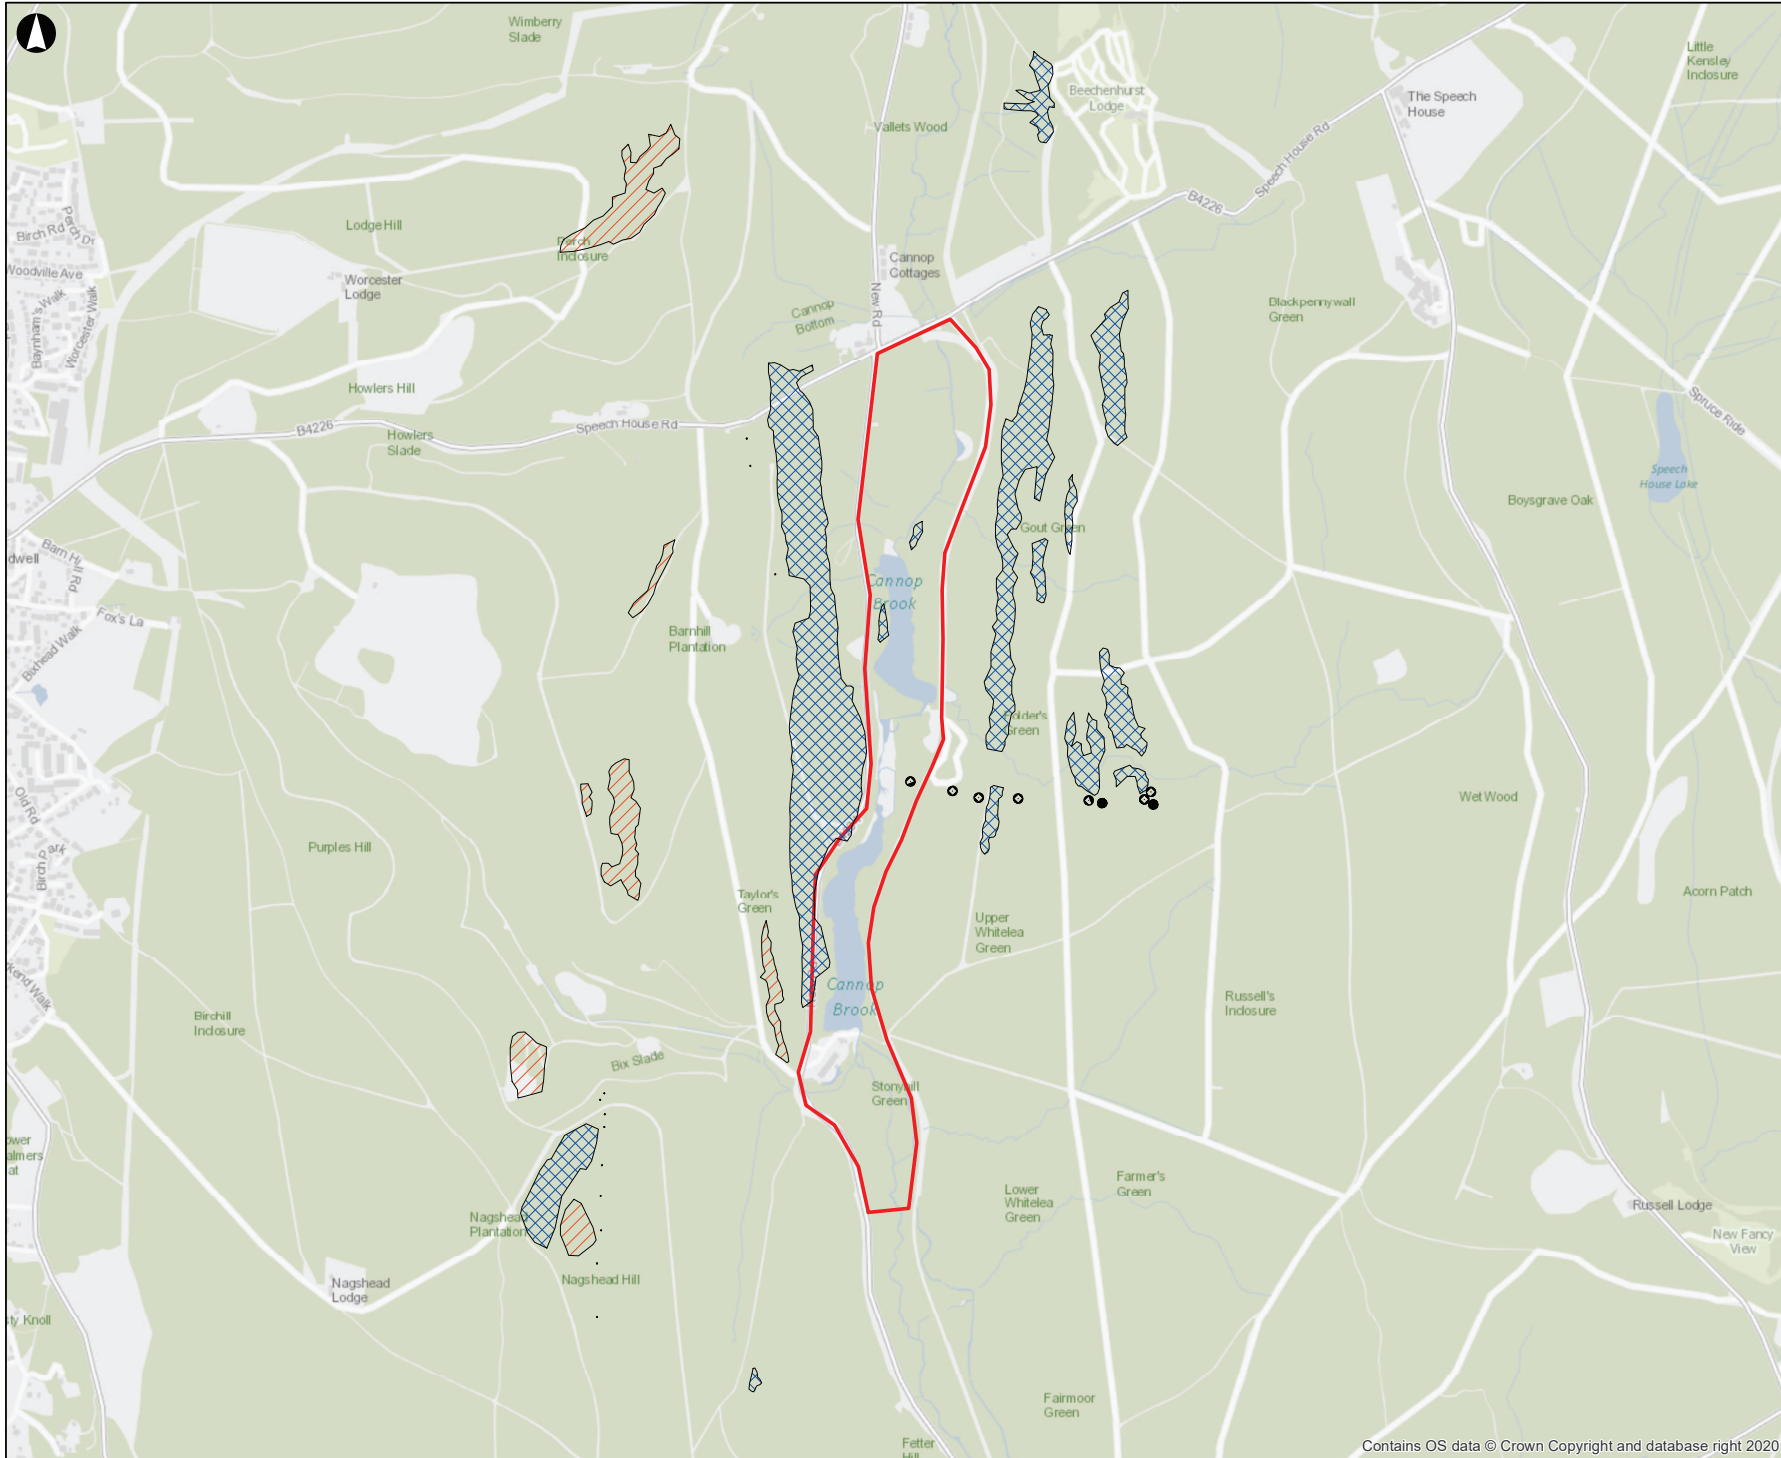
The HER has records of 72 individual potential non-designated heritage assets within the study area, ranging in date from the prehistoric to modern periods, although there is limited evidence pre-dating the 17th century. Of these, there are 18 non-designated heritage assets within the site, including the Ponds themselves, which were created in the 19th century to supply the Parkend Ironworks.

The early part of the post-medieval period was marked by considerable expansion of industrial activity within the Forest of Dean. Within the study area there is evidence of extensive quarrying, mining, charcoal burning, and ironworking dating to the post-medieval period. Figure 2 shows areas of extraction identified

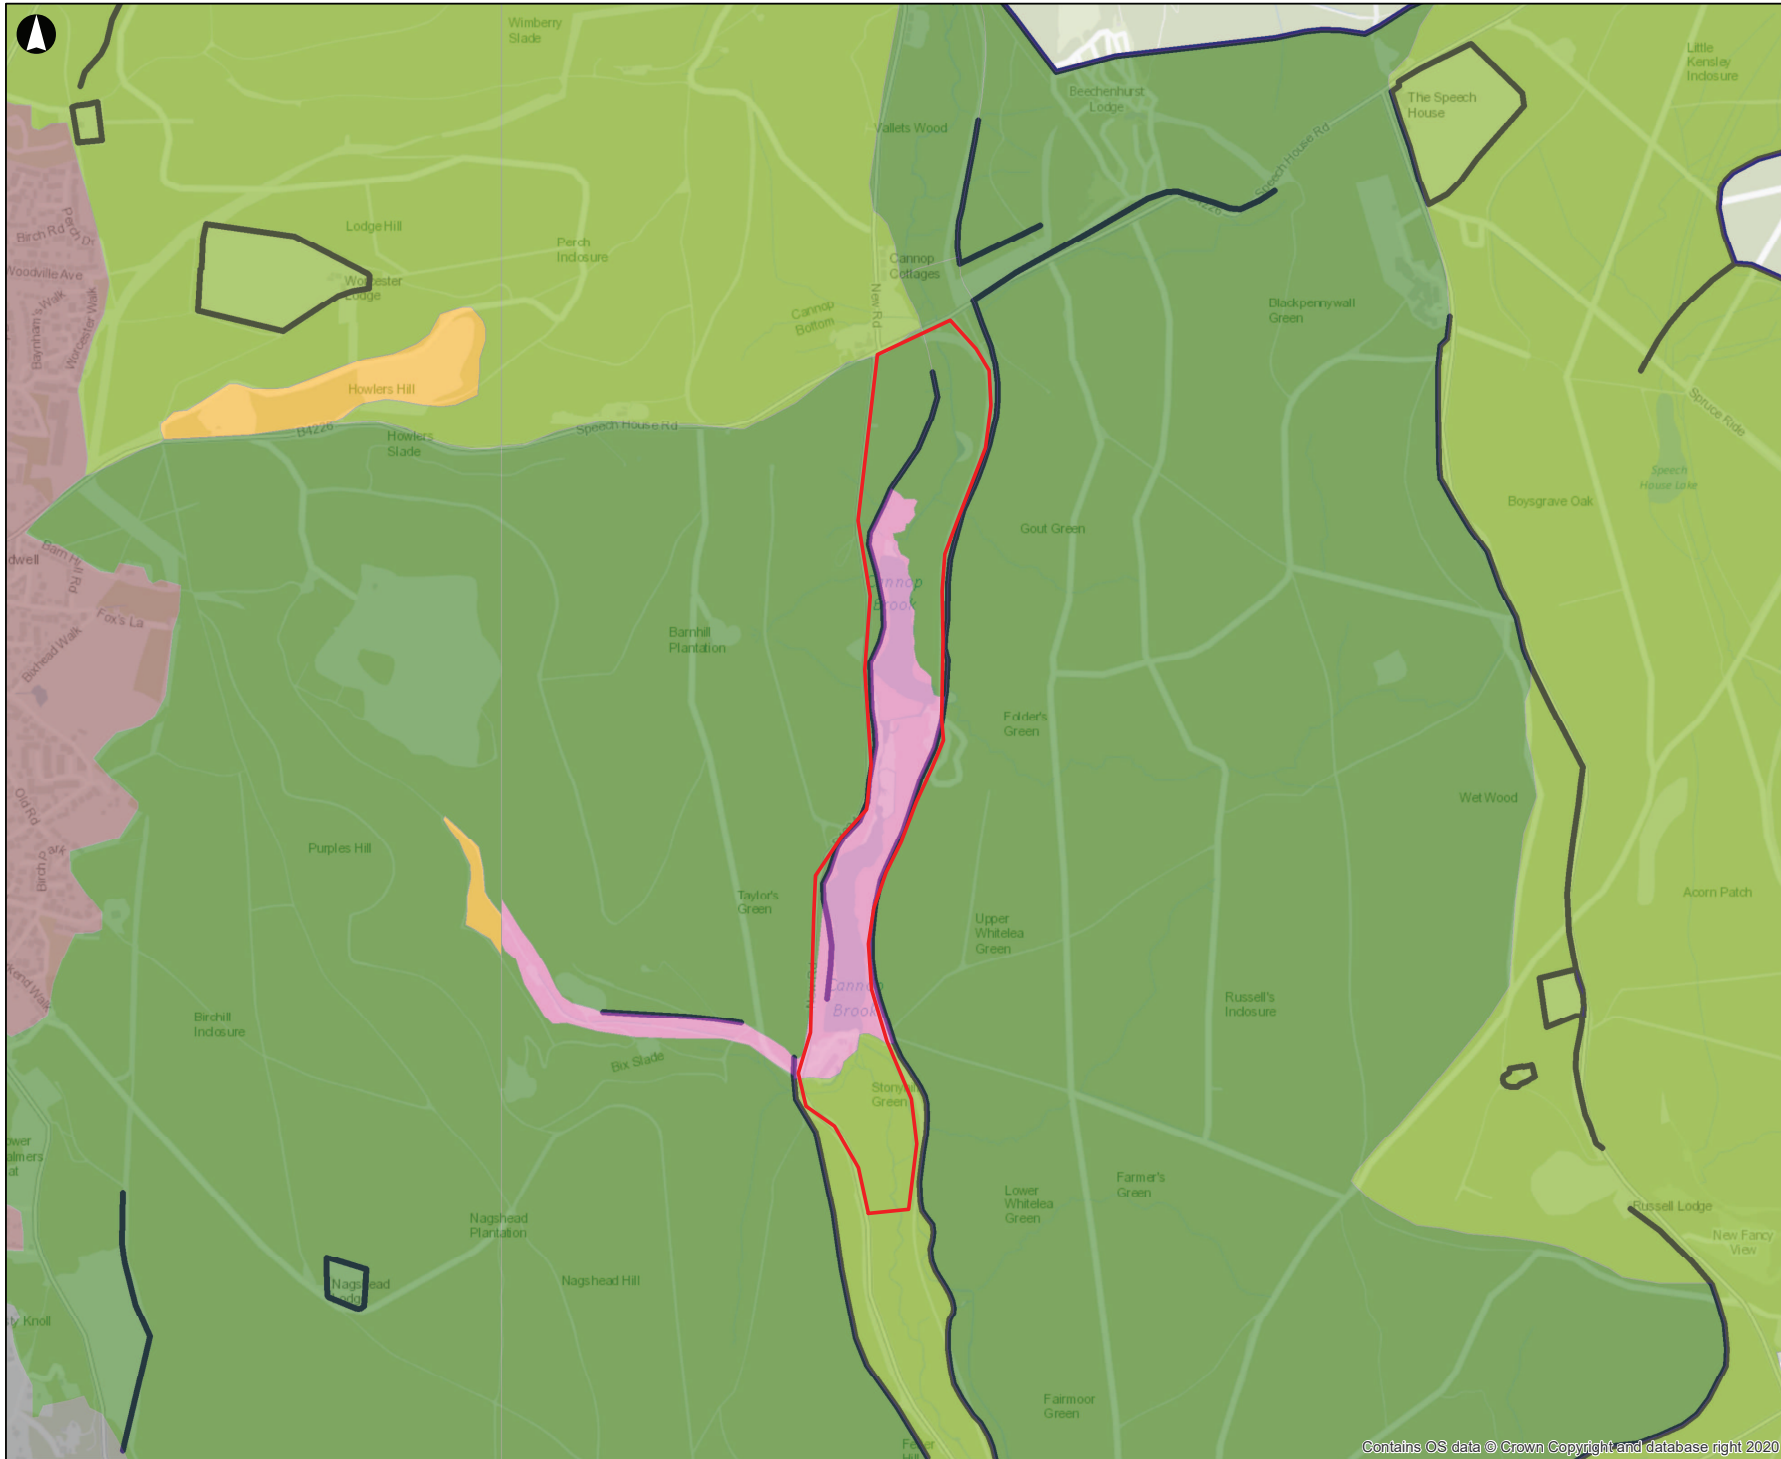
- Site Boundary
- HLC Type**
- Surviving early woodland
- Surviving early woodland?
- Disused industrial site
- Active industrial site
- Modern settlement - irregular
- Modern settlement - organised
- Crown woodland enclosure boundaries

The growth of the iron industry led to considerable deforestation for charcoal production in the 16th and 17th centuries (Baggs and Jurica, 1996). In 1668 it was recognised that the felling of trees needed to be slowed and the Dean Forest (Reafforestation) Act was brought into law. This led to the enclosure of the forest to prohibit unauthorised pasturing of livestock or extractive activities (Natural England, 2015). Figure 3 (above) shows boundaries of Crown woodland enclosure mapped within the study area. These are still visible today and were observed on the site visit (Photograph 7). The forest's timber was an important resource to the nation, vital for shipbuilding, which prompted these measures to protect supply (Baggs and Jurica, 1996). The HER includes record of drainage channels and banks in the site and study area which are likely related to tree planting and forestry management (HER: 17557, 17676). The enclosure of the forest is integral to the historic landscape character today, which remains densely wooded despite its intense industrial history (see Figure 3).

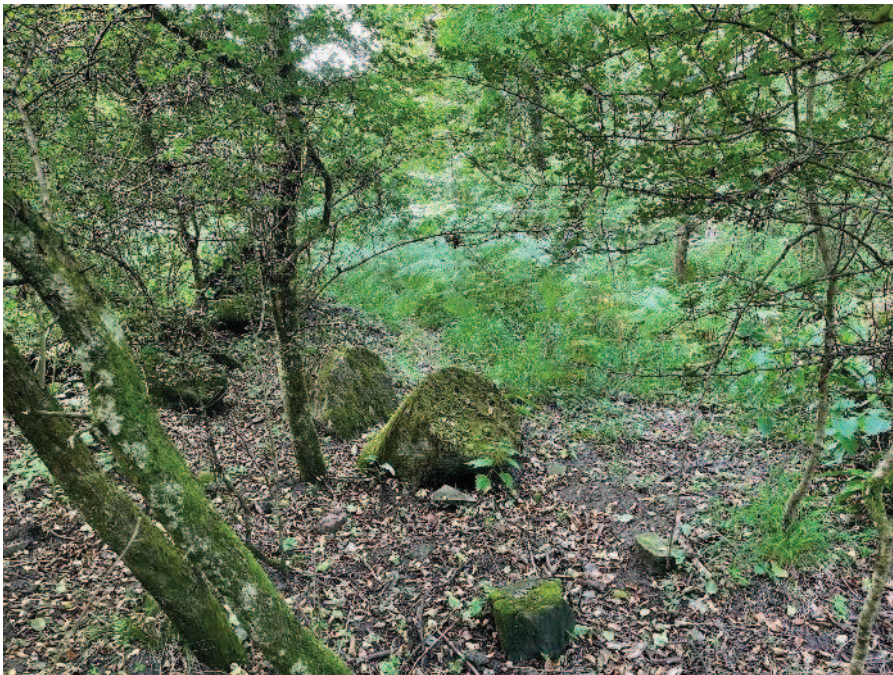
Photograph 2: Remains of Cannop Stone Works in the northern part of the site

Another significant industry in the study area is stone quarrying and cutting. There is evidence of quarrying within the site – the Lower Cannop Pond is reported to have been formed by flooding a former quarry (Baggs and Jurica, 1996) and the HER includes the site of the Cannop Stone Works in the northern part of the site (HER: 19825, Photograph 2) and hollows interpreted as stone extraction pits just north of Upper Cannop Pond (HER: 17262). South of Lower Cannop Pond is the former Bixlade Stone Works, now the Forest of Dean Stone Firms Ltd, which is thought to have been active since the 18th century (HER: 5829). The stone works processed sandstone from the Bixhead Quarries to the west (GSIA, 1992, HER: 10720). Across the study area lidar and historic maps show the locations of former quarries (HER: 10720, 17675, 17936, 17977, 20624, 22003, 22835-7). These would have produced stone for building or lime but also for immediate local use in construction within the forest.

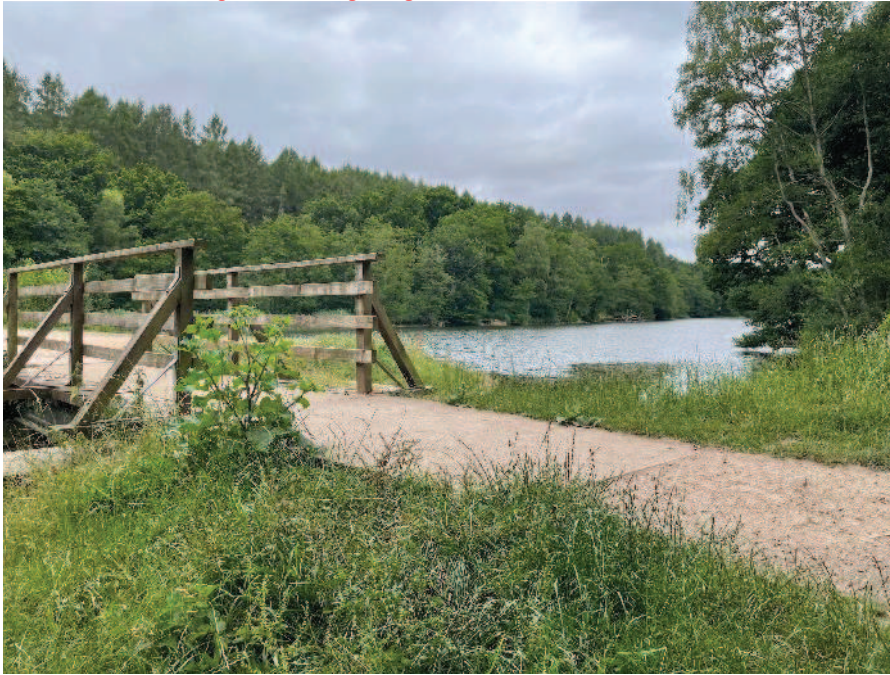
Photograph 3: View of former tramroad, looking north-west towards Lower Cannop Pond

In 1812 the Severn and Wye Tramroad, used for horse-drawn wagons, was built between Lydbrook and Lydney, with branch lines to connect industrial sites (HER: 5701). The mainline of the tramroad ran north to south to the east of the site, now followed by a cycle path. A 2km branch tramway connected Cannop Wharf to Bixhead Quarry (GSIA, 1992). This branch crosses the site immediately south of Lower Cannop Pond, now metalled and used as a footpath, although it remained in use as a horse-drawn tramway until 1947 (GSIA, 1992; Photographs 3 and 4).

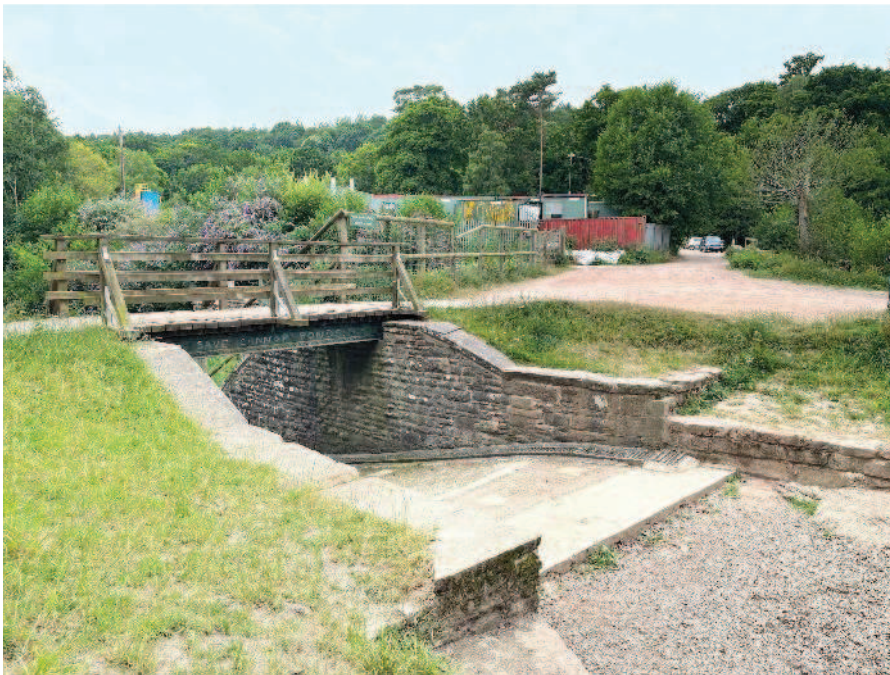
Photograph 4: Bridge carrying former tramroad over spillway, with path following tramroad towards Bixlade Quarry to the west

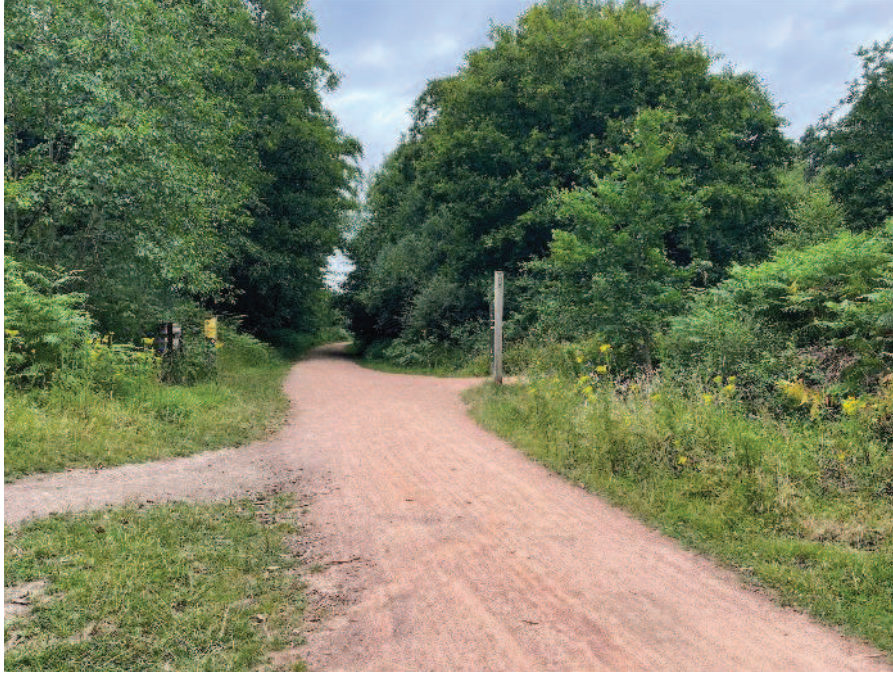
Photograph 5: Former railway line east of the Cannop Ponds

In 1868 the Severn and Wye Railway from Lydney to Lydbrook was constructed, along with branch lines and mineral loops, reusing sections of the older tramroad (HER: 5702). The railway line is now disused and dismantled but survives as a broad corridor to the east of the Cannop Ponds, with surviving traces of former loading platforms along its route (Photographs 5 and 6).

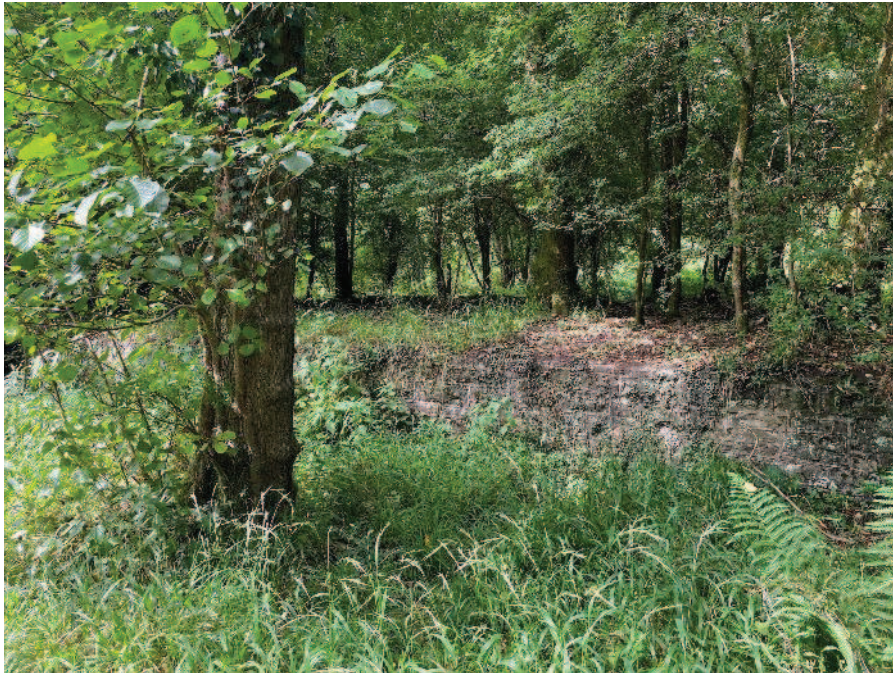
Photograph 6: Former platform to the west of the disused railway line

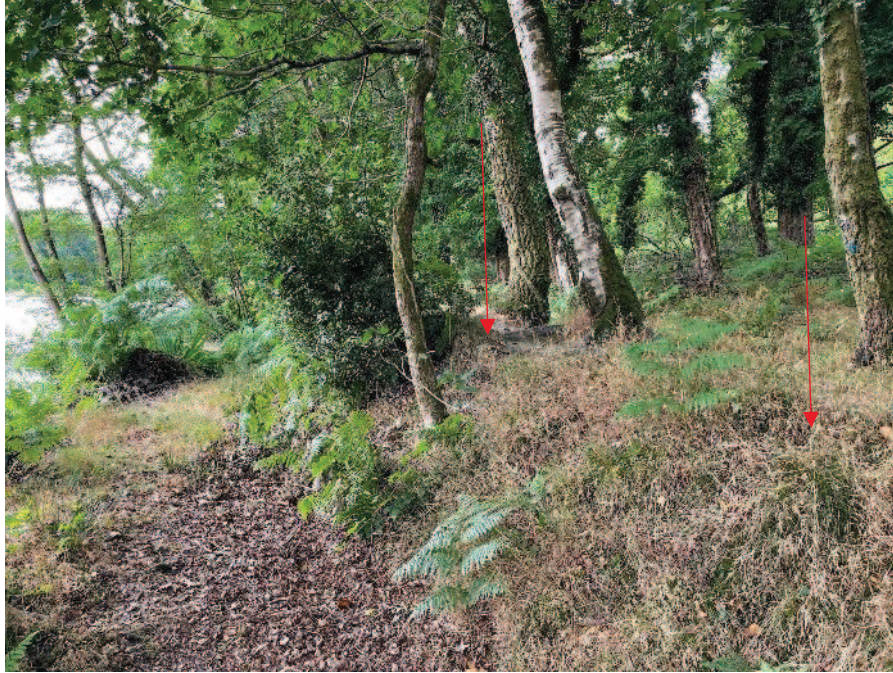
Photograph 7: Enclosure bank west of Upper Cannop Pond (red arrows indicating bank)

As well as the Ponds, there are extensive traces of tramways and disused railways across the site. This is particularly apparent in the broad corridor of the former Severn and Wye Railway, now a cycle path, but there are also former tramroads crossing south of Lower Cannop Pond and connecting former industrial sites in the north of the site. Earlier linear features include the boundaries of Crown woodland enclosure, surviving as earthworks along both sides of the Ponds (Photograph 7)

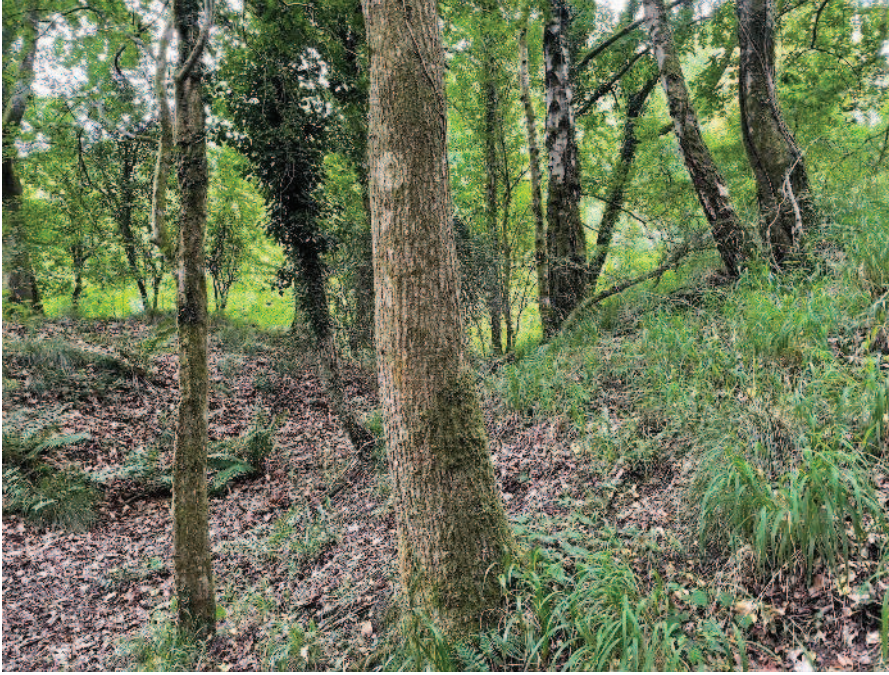
Photograph 8: Earthworks relating to colliery spoil in the central part of the site

No detailed pre-Ordnance Survey maps showing the area of the site were available to view at Gloucestershire Archives¹. The earliest map available for this assessment, therefore, was the 1831 Ordnance Survey Old Series map (1 inch to the mile) which shows the site as being formed of two long Ponds with woodland on both sides², corresponding to the documented history of the Ponds. However, although the tramroads can be seen on the map, there are no industries shown in the area of the site. The 1st edition 6”-mile Ordnance Survey map of 1883 (Figure 5) shows the site at a larger scale, allowing details of the Ponds’ shape and their associated systems of weirs, channels and sluices to be made out. The Severn & Wye Railway had replaced the former tramway along the eastern side of the Cannop valley, connecting to the tramroad which continued westwards along the southern bank of Lower Cannop Pond towards the Bixlade Quarries. Both Ponds used sluices and weirs to control the flow of water out from the Ponds, with dams to retain the water levels. Although not labelled, the leat which had been created to feed the Parkend Ironworks can be seen to the south-east of Lower Cannop Pond. An area of colliery spoil, associated with the ‘Whitelea Colliery (disused)’ to the east of the Ponds, covered part of the area between the Upper and Lower Ponds. This can be observed as earthworks on the site today (Photograph 8).

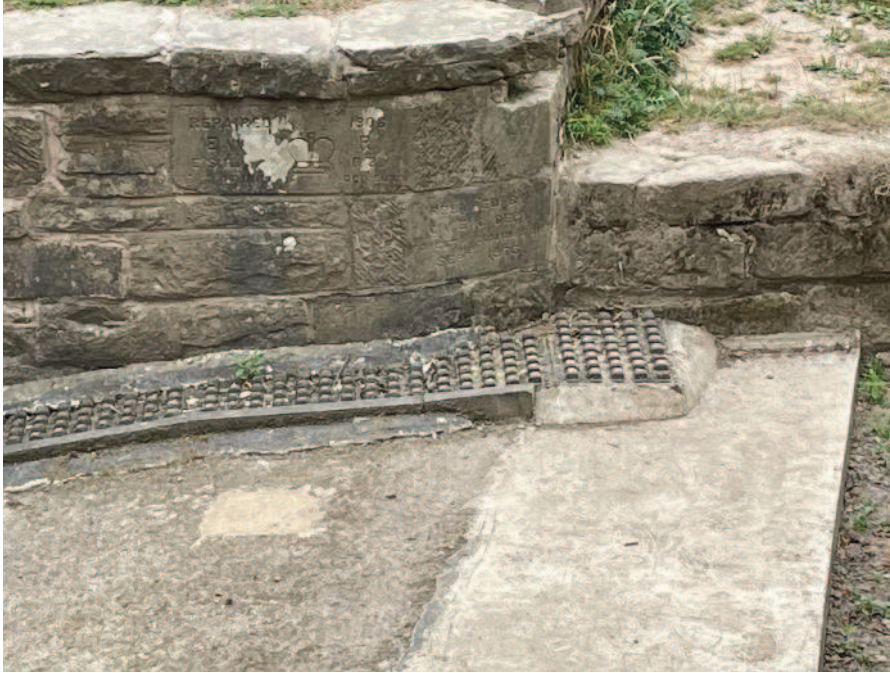
Photograph 9: Records of works carved into the stonework at Lower Cannop weir

The Ponds themselves were modified in the early years of the 20th century following issues of leaking, low water levels and pollution. From at least the late 19th century the Ponds, although initially built to supply water to the Parkend Ironworks, had been stocked for fishing. Letters held in the Gloucestershire Archives detail repeated complaints about dying fish resulting from low water levels and water pollution (D9096.F3.874). There are records of repairs, estimated as £202.15.19 in 1904, including works to the Lower Cannop spillway. These repairs, along with further works in 1976, are recorded in the stonework on the Lower Cannop weir (Photograph 9). The early 20th century works were designed to raise the water levels in the Ponds and enable it for use by the Bixlade Stone Works and the railway. Although the majority of the changes are too small to be seen in the revised Ordnance Survey mapping (Figure 6), the higher water levels can be seen from the increased size of the Ponds, particularly the upper Pond, which extended further up the Cannop valley forming marshy ground. Although only the major works are apparent in the engraved stone, it is clear that maintenance was undertaken throughout the 20th century. For example, a letter dated 15th May 1909 states that a leak was developing in the bank of the lower Pond (D9096.F3.874).

- Weirs, spillways and sluices: these features are of both archaeological and, potentially, architectural interest. Engravings indicate that there have been multiple phases of repair and reconstruction but there may be unseen elements of the earlier structures which would be of interest.

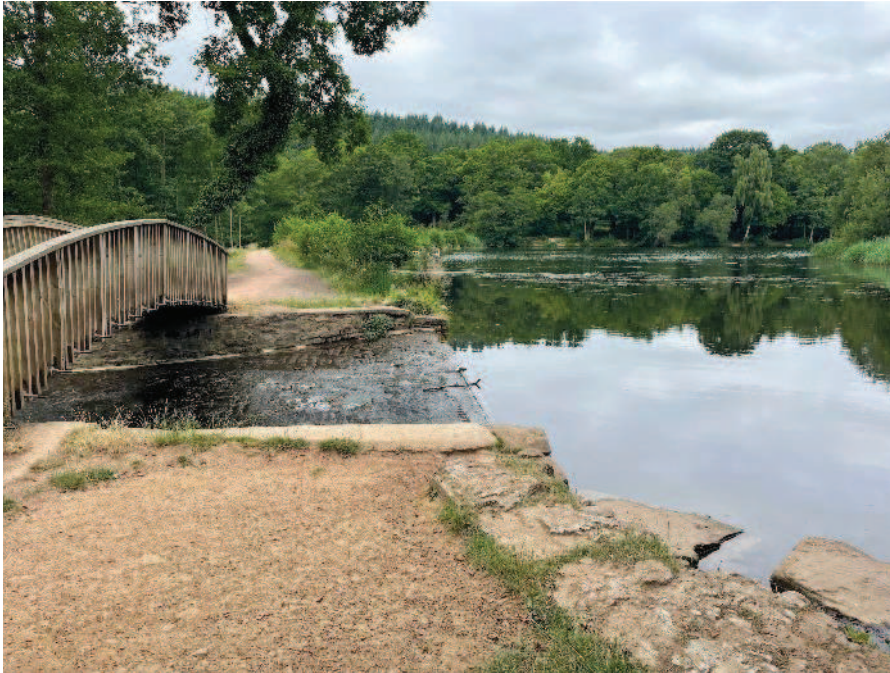
Photograph 10: Upper Cannop Pond, including spillway and slag edging

The Ponds date to the 19th century and were created by damming and flooding a section of the Cannop Valley. Associated with the Ponds there are numerous features which are of archaeological interest, including weirs, sluices, bridges and the dam structures. Although appearing naturalistic, there is little about the Ponds which has a natural origin. Photograph 10 and Photograph 11 are examples of this, showing the slag edging around the Upper Cannop Pond and the substantial earthen embankment which was constructed to hold the water. Features of archaeological interest associated with the Ponds have been present around the water's edge and further features are likely to be present, particularly within the Pond embankments.

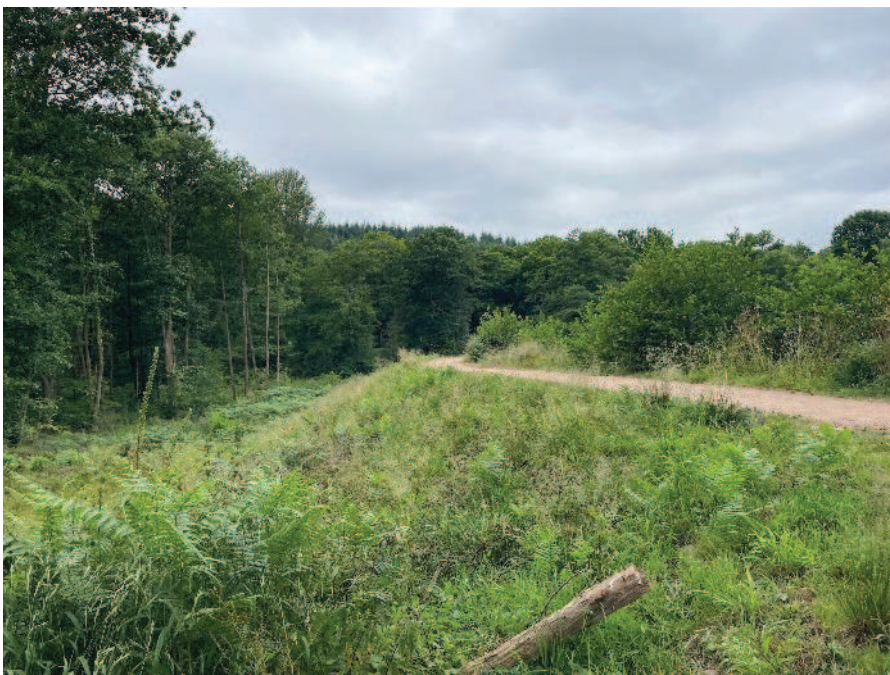
Photograph 11: Upper Cannop Pond embankment

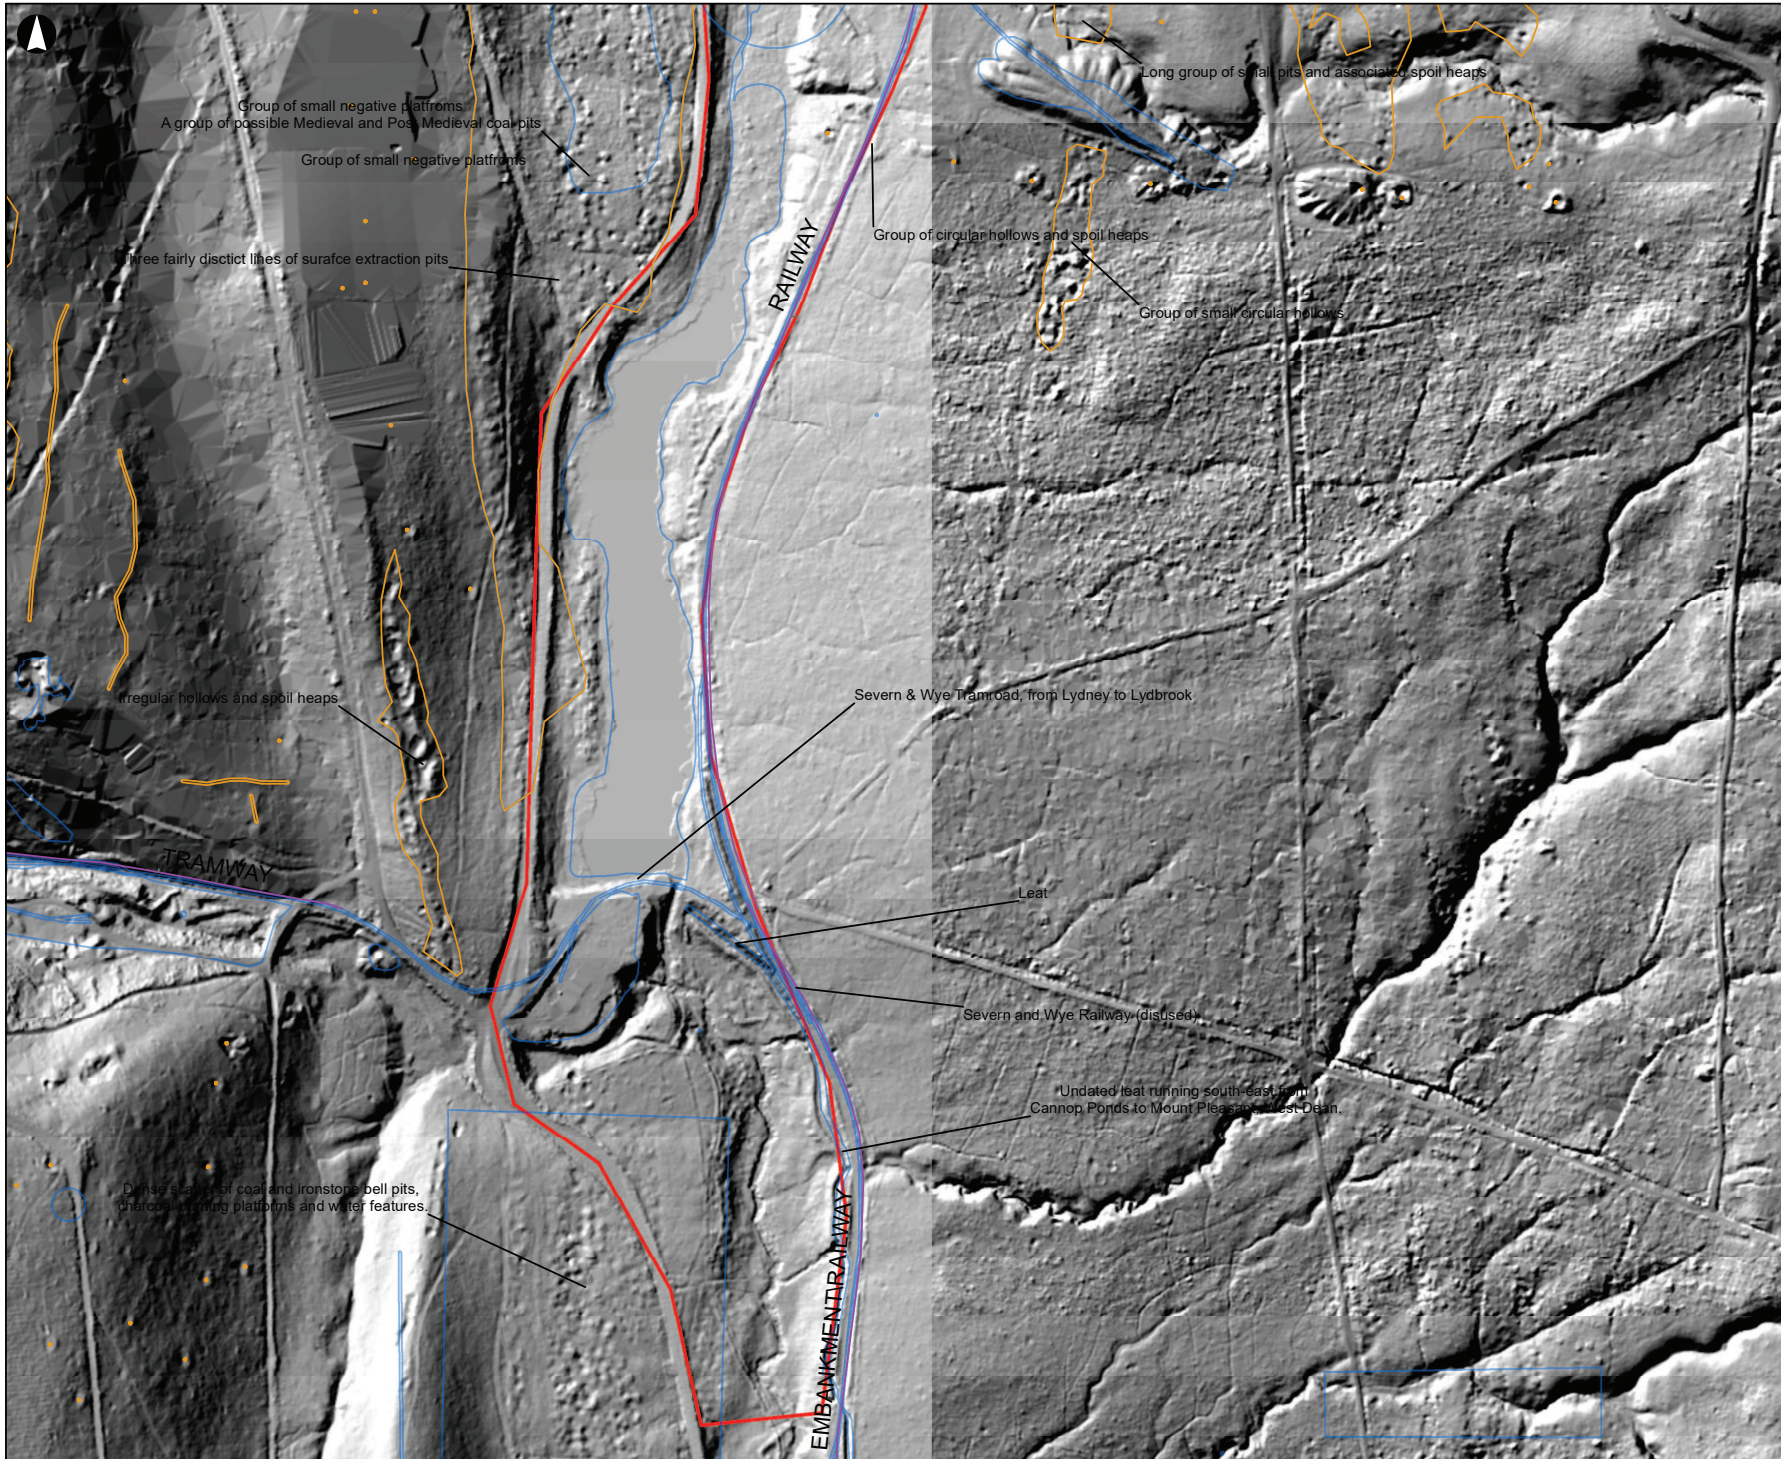
Figure 10: Lidar (1m DTM) with annotation (South)

- NMP Lines
- Lidar (2006 survey)
- HER records
- Site Boundary

In addition to the heritage assets identified above, there are several earthworks present within the site, including a C-shaped trench (HER: 20694) and a horseshoe-shaped ditch (HER: 17488), both identified from lidar data, which are undated (see section 2.10).

Features identified from lidar data, as well as the unannotated lidar imagery, are shown in Figure 7-Figure 10.
