INTRODUCTION

PROVISION OF LONG TERM REPAIR AND ENHANCEMENT WORK ON LOWER CANNOP POND DAM

2nd March 2023

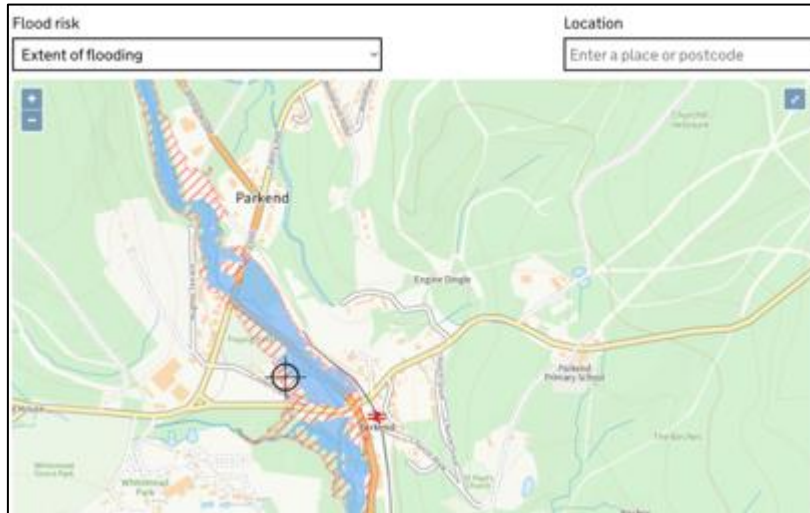
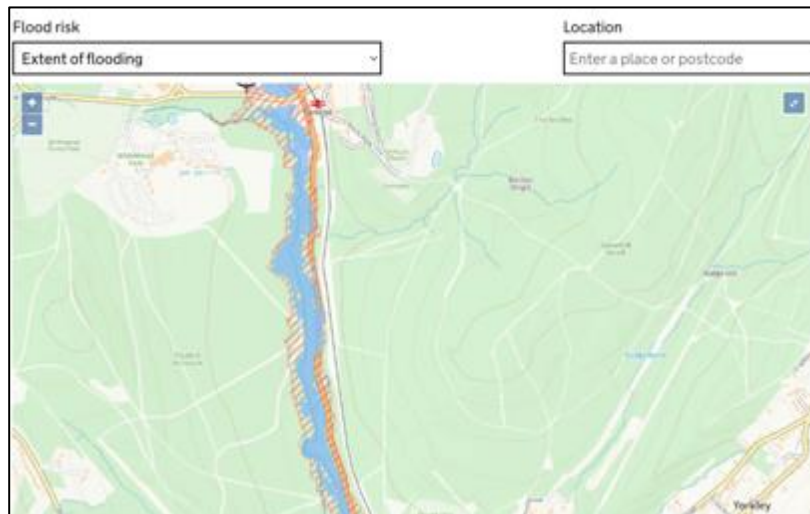
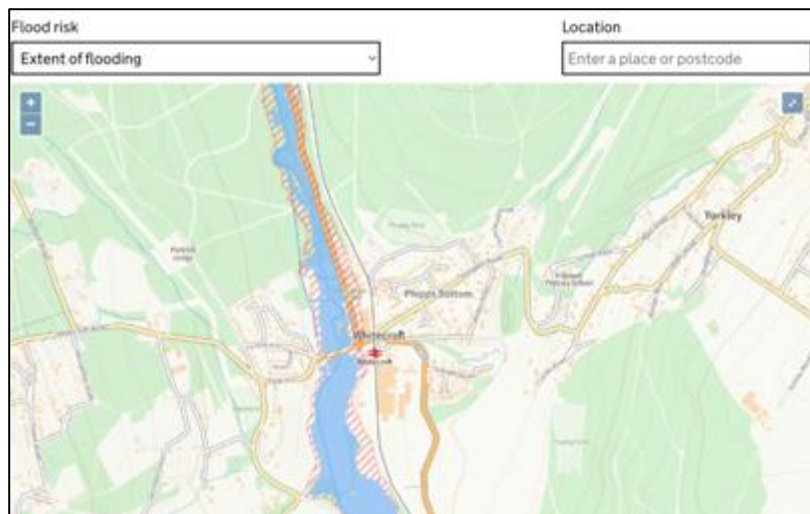
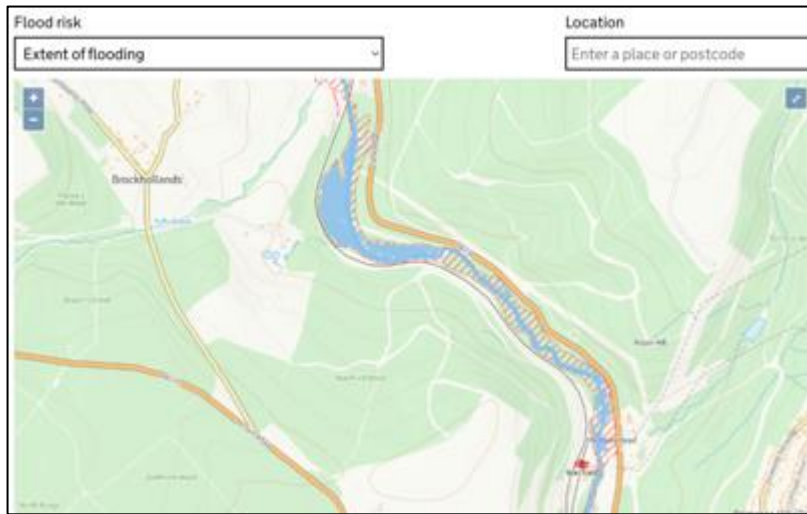
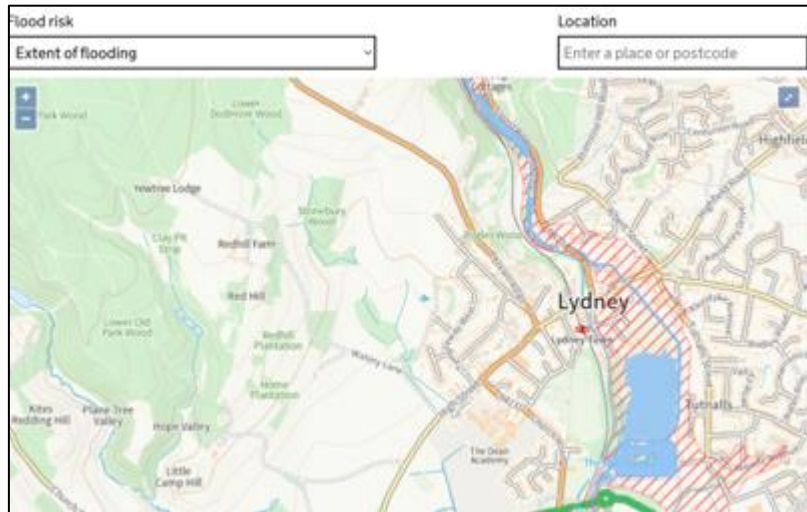
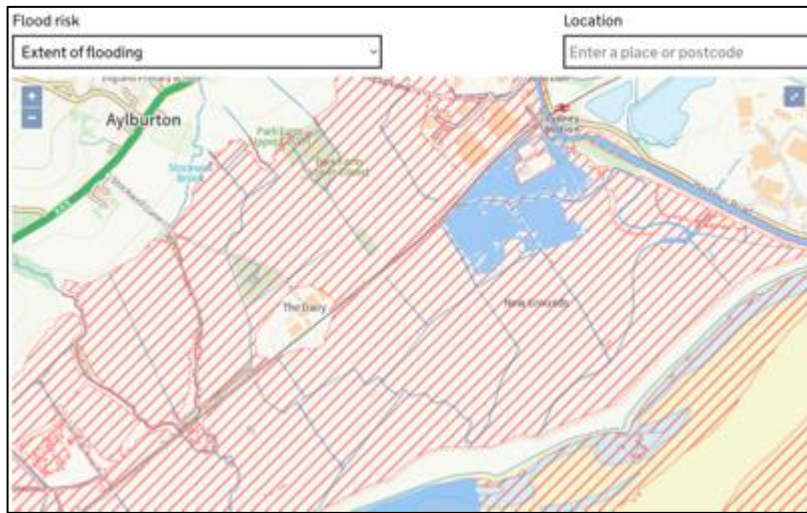
The flood plans can be accessed from the following website, using GL15 4JE and select Holmdale.
